Tohoku Chapter, Architectural Institute of Japan  
Reconnaissance Report (11) on Building Damage in Kurihara City  
The 2011 off the Pacific Coast of Tohoku Earthquake  
Released on March 28, 2011

Professor Masato Motosaka, Graduate School of Engineering,  
Tohoku University  
(Translated by Shunsuke Otani, University of Tokyo)

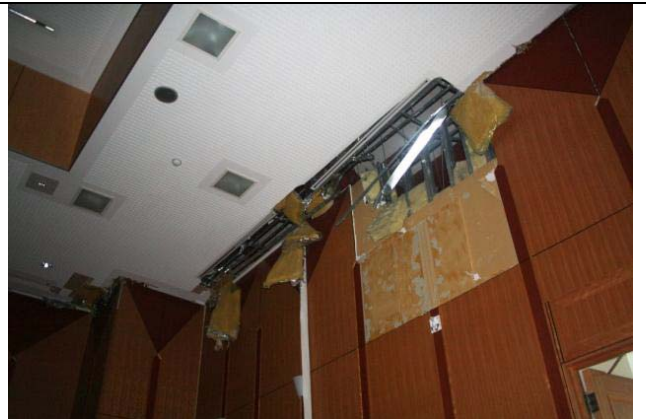
In the Kurihara City Municipal Office Building (4-story reinforced concrete building), the ceiling of City Municipal Assembly Hall fell in the fourth floor and finishing tiles on a reinforced concrete column fell; no structural damage was observed (Photo 1).

(b) Fall of ceiling of Municipal Assembly Hall (1)

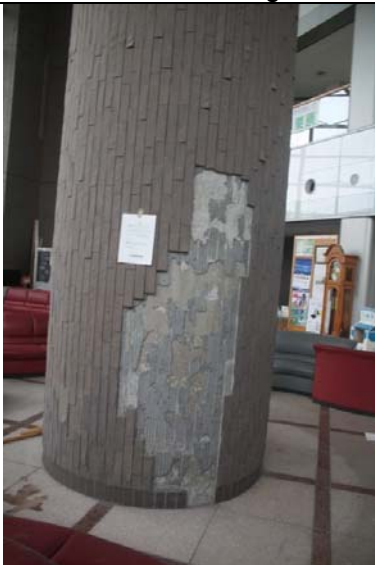
(c) Fall of finishing tiles on a column

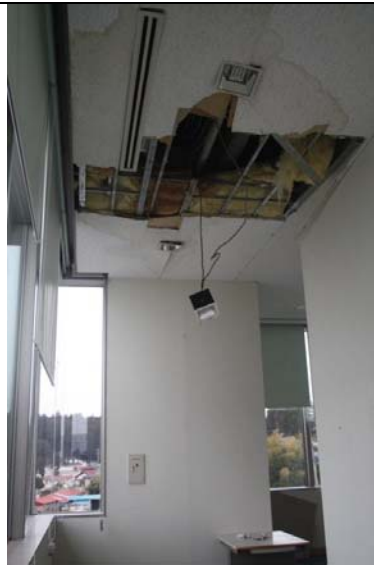
(d) Fall of ceiling of Municipal Assembly Hall (2)

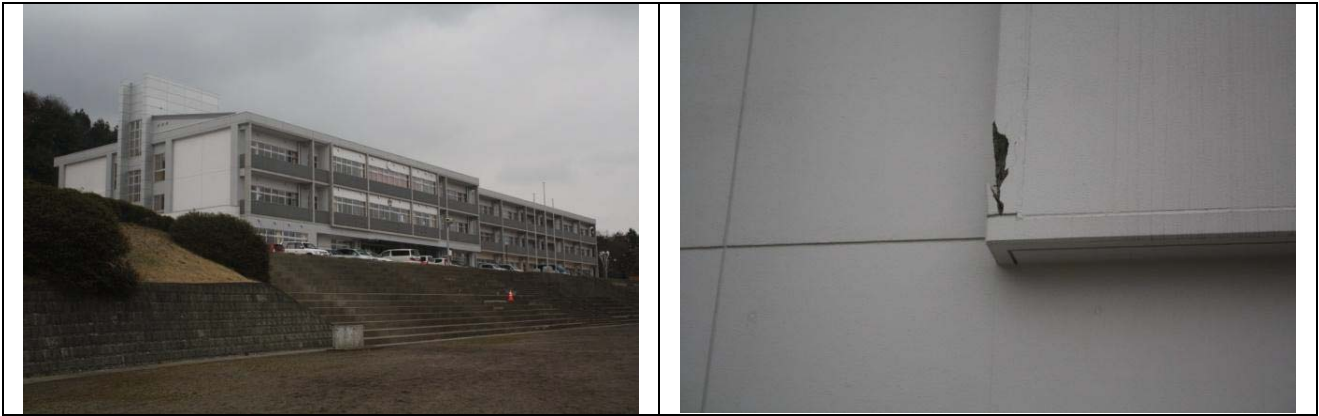
Two buildings near the K-NET Tsukidate station were selected for the damage investigation; Kurihara City Municipal Tsukidate Junior High School (new construction, Photo 2) and Kurihara City Municipal Tsukidate Gymnasium Center Building (Photo 3), the latter suffered non-structural damage during the 2008 Iwate-Miyagi Inland Earthquake. No damage was observed in both buildings.

Photo 2: Tsukidate Junior High School Building with minor non-structural damage

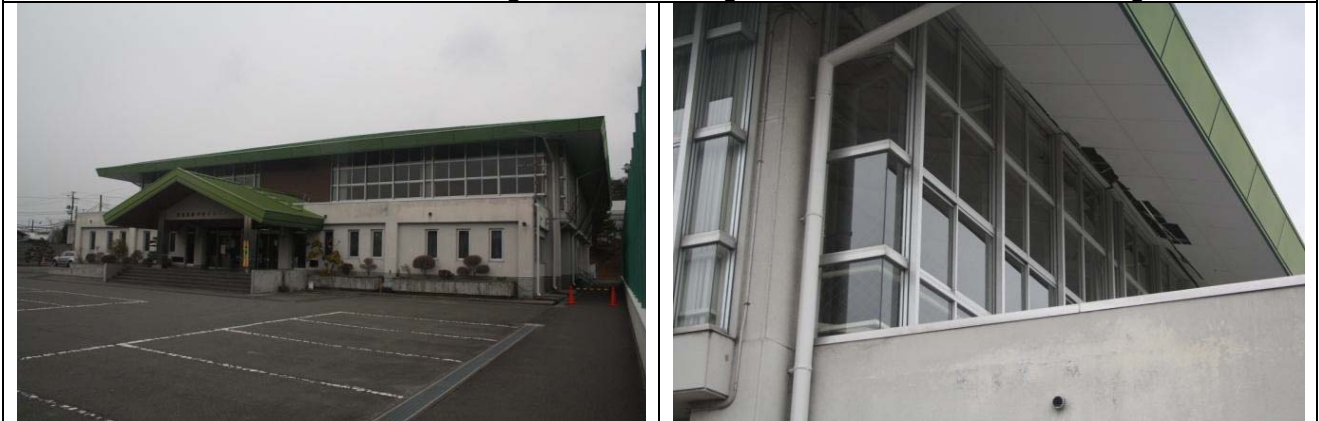
Photo 3: Tsukidate Gymnasium Center Building with minor non-structural damage

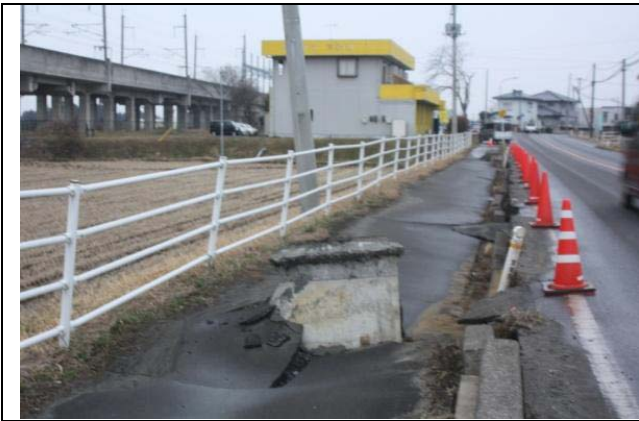
Soil liquefaction phenomena were observed on the road to National Route 398 in Shiwahime District; i.e., a man hole was lifted (Photo 4). Fall of masonry walls along the plot periphery was seen in several locations (Photo 5). Concrete block walls did not fall, but heavy masonry walls fell down (Photo 6). When the investigator asked an old man at a parking lot near Shiwahime Municipal Branch how he compared the intensities of ground motion of the 2011 Tohoku earthquake and the 1978 Miyagi-ken Oki Earthquake, he said “the ground motion intensity of this earthquake was larger and the duration was longer. Compared with the 2008 Iwate-Miyagi Inland Earthquake, the ground motion intensity of this earthquake was larger.”

Photo 4: Lifting of a man hole due to soil liquefaction near Shiwahime

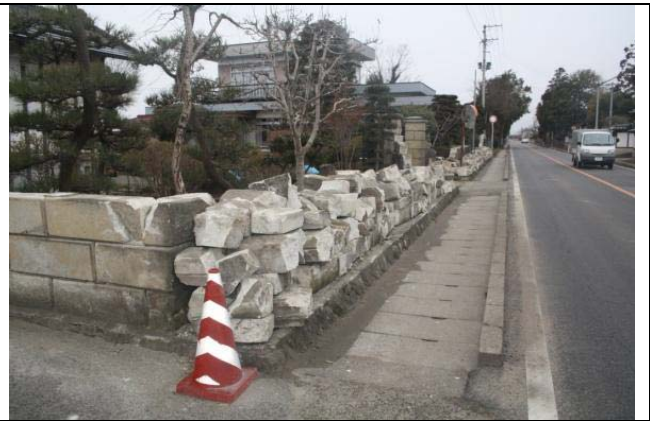
Photo 5: Fall of masonry walls

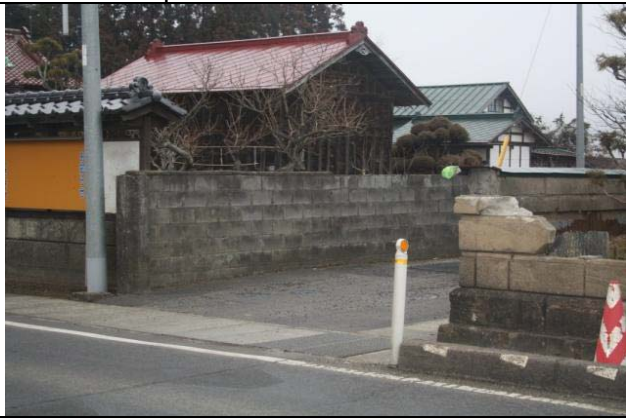
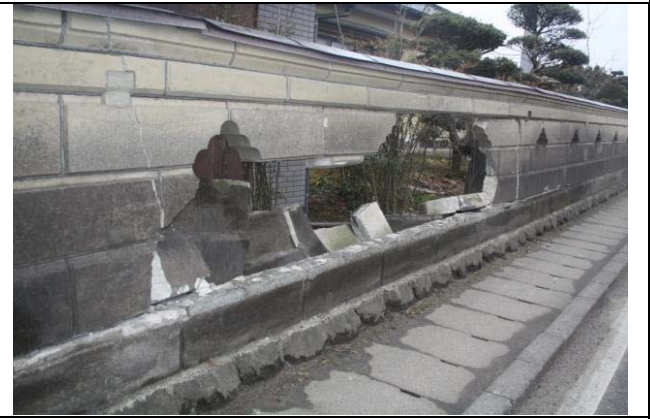
Photo 6: Undamaged concrete block walls and damaged masonry walls

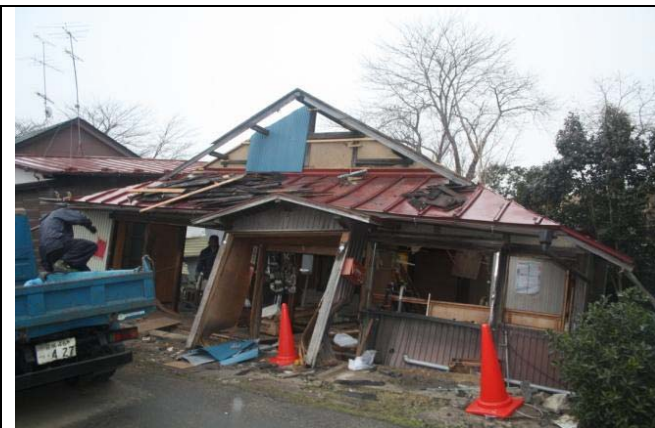
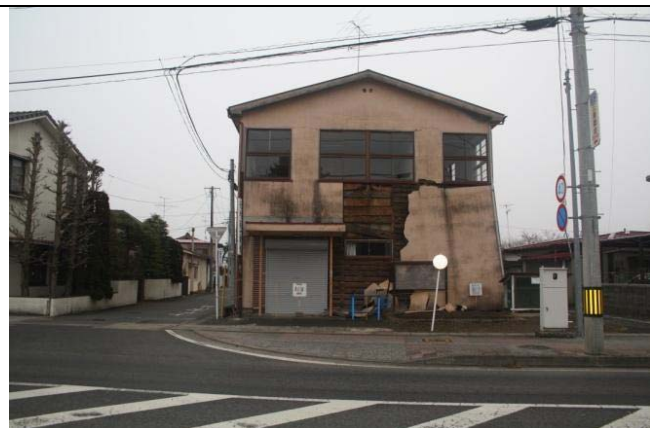
Along the Hazama River in Wakayanagi-machi, the damage of old timber houses was observed (Photo 7)

Photo 7: Damage of houses in urban area of Wakayanagi-machi

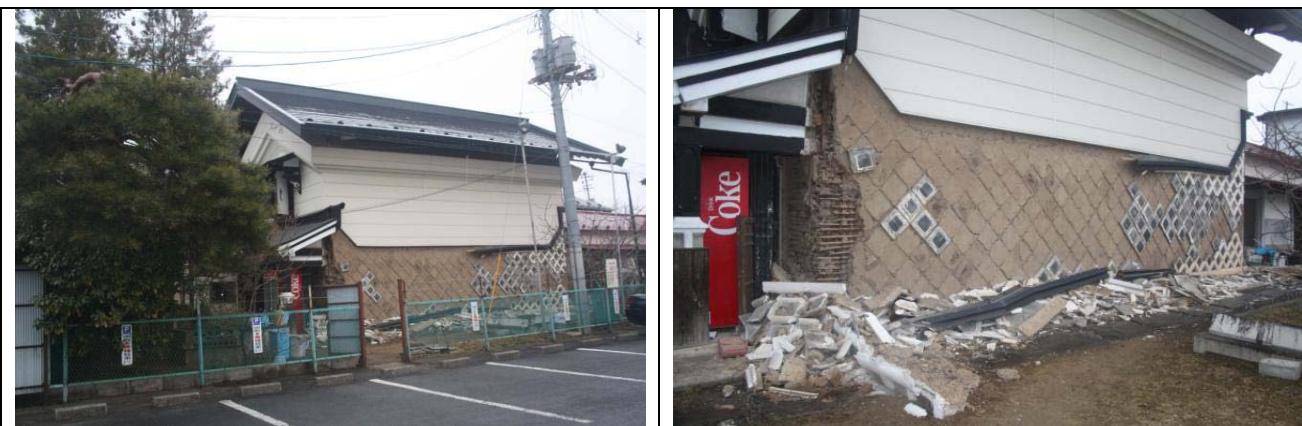
Mud exterior finishing fell from old traditional ware houses (Photo 8)

Photo 8: Fall of exterior mud finishing of traditional ware house walls

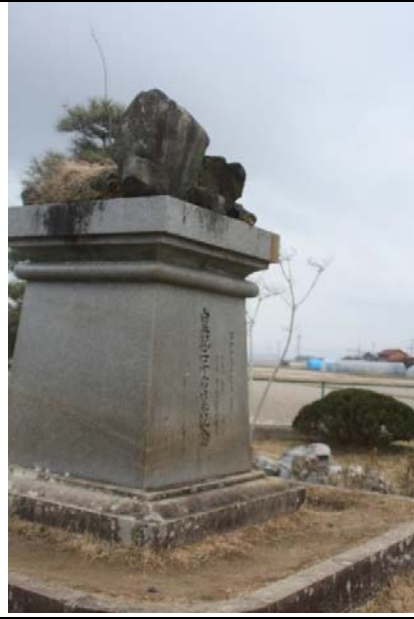
Photo 11: Fall of a statute

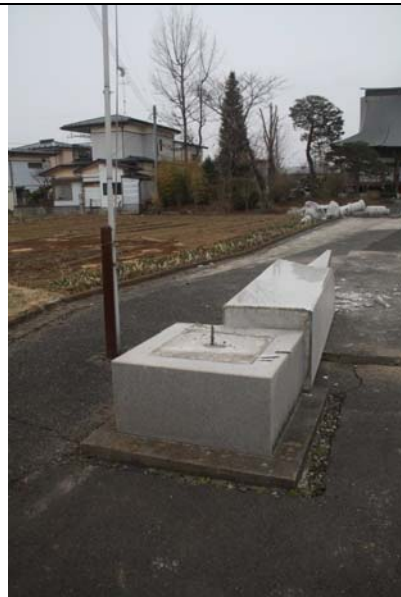
Photo 12: Fall down of two gateposts of the Kanro-ji temple to west

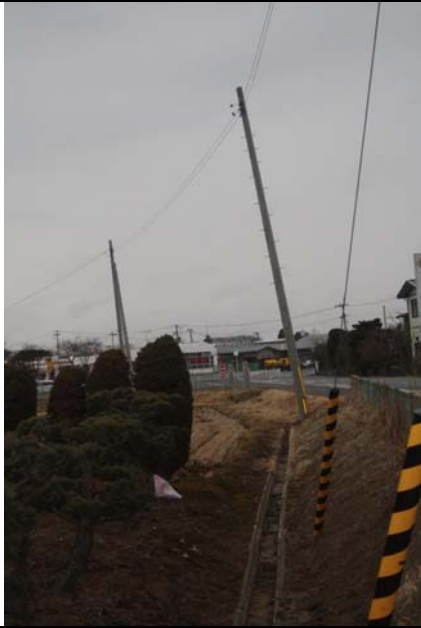
Photo 13: Tilting of utility poles
