## Aluminum Alloys: Metallographic Techniques and Microstructures

### Atlas of Microstructures for Aluminum Alloys

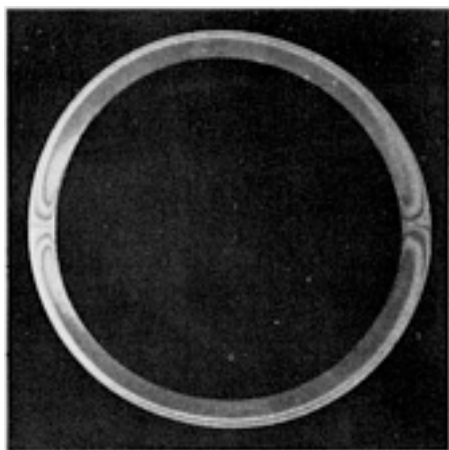
**Fig. 3** Alloy 3003-F tube, extruded through a two-port bridge die. The bands of fine precipitate

show pattern of metal flow and the areas where the metal entering through the two ports was welded together in the die. Caustic fluoride. 5×

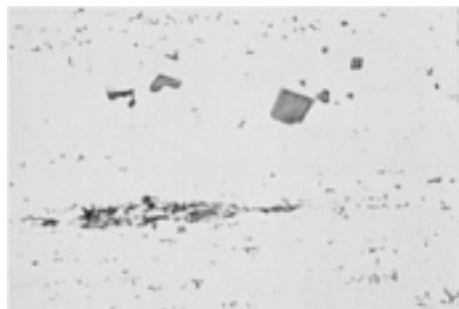
**Fig. 4** Alloy 3003-F sheet, hot rolled. Longitudinal section shows stringer of oxide from an inclusion in the cast ingot and particles of phases that contain manganese, both primary (large, angular) and eutectic (small). As-polished. 500×

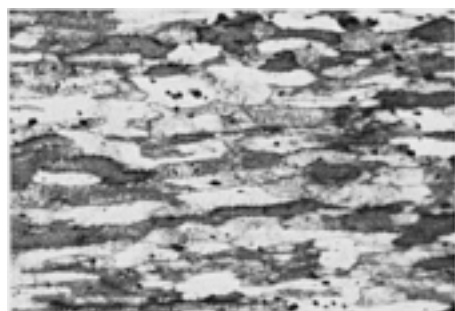
**Fig. 5** Alloy 3003-O sheet, annealed. Longitudinal section shows recrystallized grains. Grain elongation indicates rolling direction, but not the crystallographic orientation within each grain. Polarized light. Barker's reagent. 100×

**Fig. 6** Same alloy and condition as for [Fig. 5](#), but shown at a higher magnification. Dispersion of insoluble particles of  $(Fe,Mn)Al_6$  (large) and aluminum-manganese-silicon (both large and small) was not changed by annealing. 0.5% HF. 750×

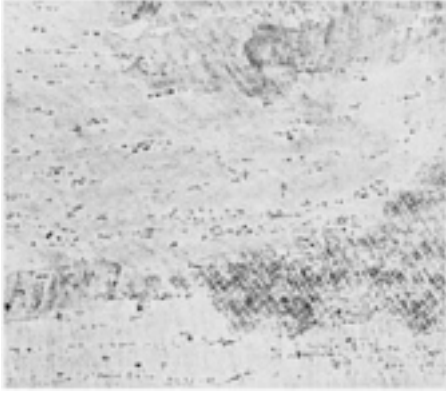
**Fig. 54** Same alloy and heat treatment as [Fig. 53](#), but showing no recrystallization of the worked structure. Note the large amount of slip (light parallel lines) that has occurred on two sets of slip planes. Keller's reagent. 100×
