Austenitic Manganese Steel Castings: Metallographic Techniques and Microstructures

Atlas of Microstructures for Austenitic Manganese Steel Castings

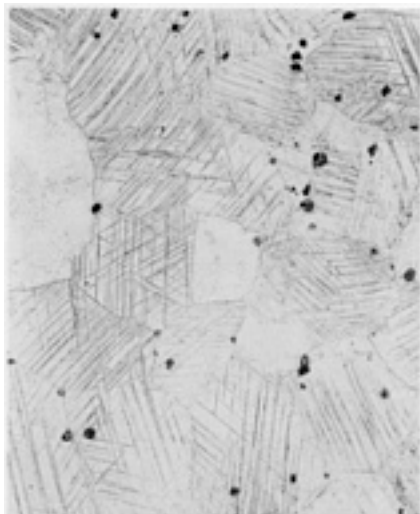
Fig. 6 ASTM A128 alloy, cast and heat treated at 1065 °C (1950 °F), water quenched, machined into tensile specimen, and tested. Austenite grains show different amounts of twinning, depending on individual grain orientation. Etchant: Same as [Fig. 5](#). 100×

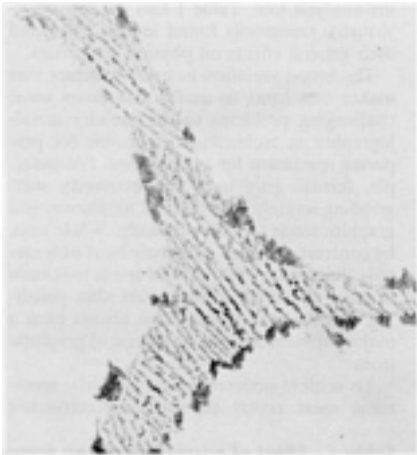
Fig. 13 ASTM A128 grade A alloy, cast and deliberately overheated to 1205 °C (2200 °F) for 1 h, then water quenched. Photomicrograph illustrates a triple point in the austenite grain structure, with detail of the eutectic pattern of incipient fusion associated with the carbide due to excessive solutionizing temperature. Cyclic etch (see [Table 1](#) for composition and method). 500×
