Copper and Copper Alloys: Metallographic Techniques and Microstructures

Atlas of Microstructures for Copper and Copper Alloys

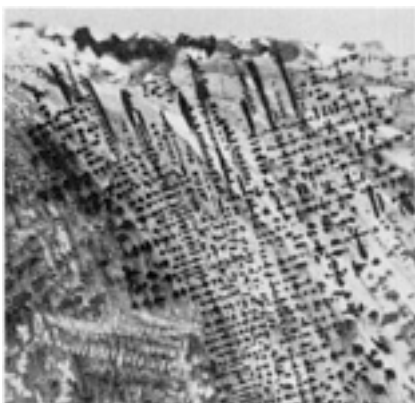
Fig. 3 Same material as [Fig. 1](#), static cast. Grains from the chilled bottom grew through the dendrite "skeletons," producing a mixed grain structure, Etchant 10, [Table 3](#). 3x

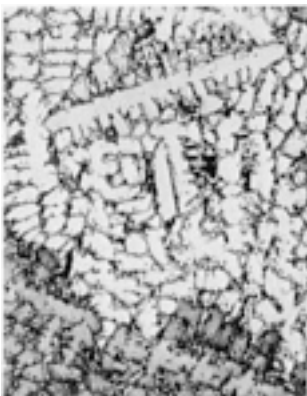
Fig. 7 Same material as [Fig. 6](#), with primary dendrites of α phase darkened. Lead appears as small spheroids. Etchant 1, [Table 3](#). 50×. (J. Dibee)

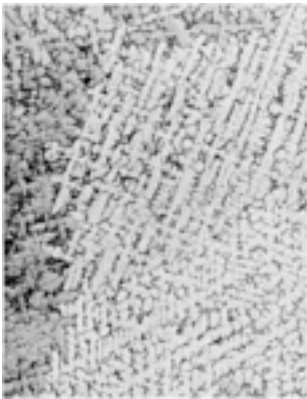
Same alloy as [Fig. 6](#), semicontinuous cast. [Fig. 9](#): α -phase dendrites in the columnar zone near the outside edge of the ingot. [Fig. 10](#): mixed α - and β -phase dendrites near the center of the ingot. Etchant 1, [Table 3](#) 30 \times . ([Ref 1](#))

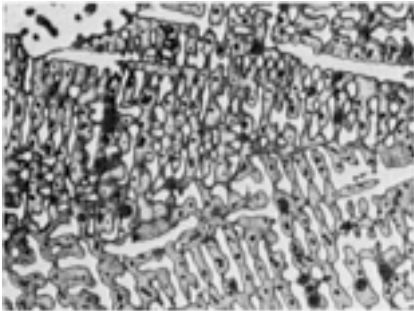
Fig. 16 Same as [Fig. 15](#), except at higher magnification to reveal more detail of the structure. Same etchants as [Fig. 15](#). 75×. (J. Dibee)

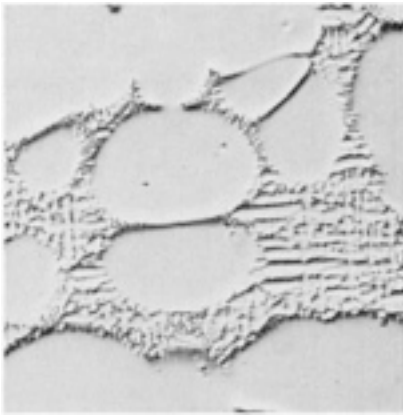
Fig. 19 Same alloy and processing as [Fig. 18](#). Higher magnification shows that fine dendrites originate in the coarse ones and have the same orientation. Dendrites starting in directions that are not $\langle 100 \rangle$ do not grow very far. Same etchant and electrolyte as [Fig. 18](#). 85 \times . (J. Dibee)

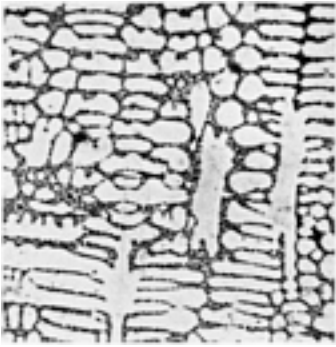
The effect of oxygen content on the microstructure of as-cast, copper-oxygen alloys. Oxygen contents less than 0.39% result in primary dendrites of copper (light) plus eutectic (mottled areas of small, round oxide in copper). [Fig. 23](#): 0.024% O. [Fig. 24](#): 0.05% O. [Fig. 25](#): 0.09% O. [Fig. 26](#): 0.18% O. As-polished. 100×

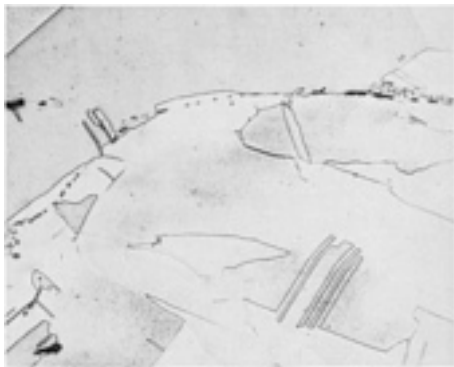
Fig. 43 Copper 12500 (FRTP copper) hot-rolled strip 12.7 mm (0.5 in.) thick. Structure consists of twinned grains of copper, with stringers of Cu_2O particles resulting from segregation of the oxide in the ingot during casting. Etchant 1, [Table 3](#). 200×
