Preliminary report on the landslides of 5 May 1998, Campania, southern Italy

M. Del Prete, F. M. Guadagno, A. B. Hawkins

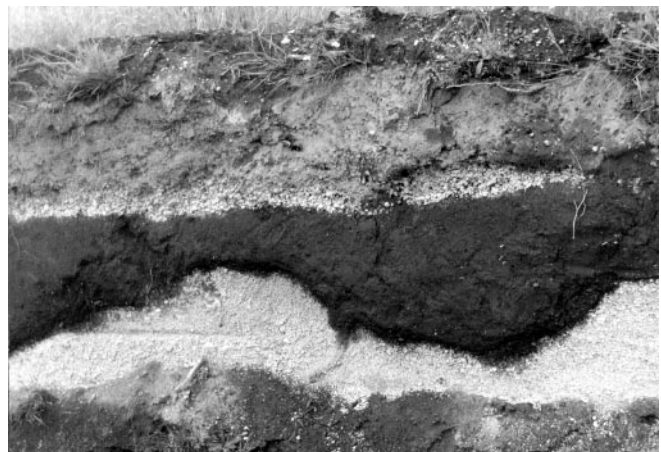
Fig. 5

Typical pyroclastic deposit showing variation in individual layer thicknesses

As would be expected, therefore, the pyroclastic mantle varies in thickness (Fig. 5). This was controlled in part by geographical location, in part by the relief on which the deposits accumulated and also by the surface morphology of the wind-blown deposits as they stabilised and the process of soil formation began. At the top of P. zo d'Alvano, for instance, the cover is thin yet on the lower parts of the hill slope it is sometimes several metres thick (Celico et al. 1986). Not surprisingly, where thick limestone bands and associated topographical steps are present, the deposits are

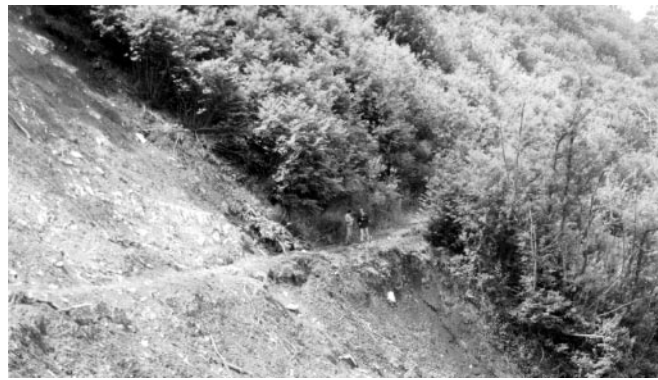
Fig. 8

Typical trackway cut into the hill slope. Note extensive accumulation of material immediately downslope

2. In some areas relatively straight failures also occur where trackways have recently been cut into the hill slope (see Fig. 8). Although these have been excavated mainly in the pyroclastic veneer, in some areas the trackways have involved limited excavation within the bedrock. These trackways would undoubtedly interrupt the normal downslope flow of surface water which would then be diverted along these partially unvegetated linear features. Where the volume of such flows was relatively high and weak zones were present on the downslope side, initial spillage of water could lead to failure of the downslope side of the trackway, through which the water would be diverted to create new channels within the uncemented pyroclastic veneer. This could account for the reported sudden rise in water in the Quindici culvert, followed by debris material as the mass movement developed at the head of the failure zone.

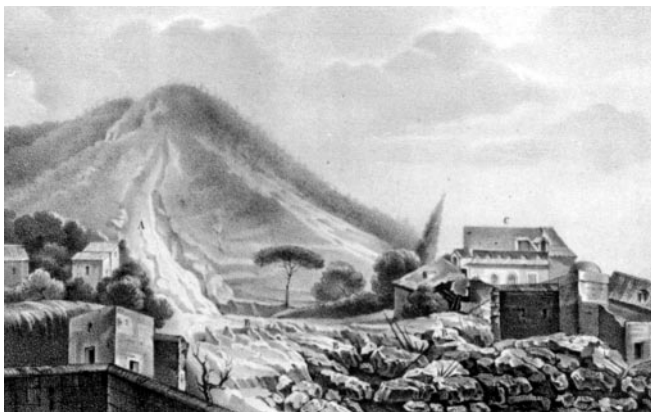
**Fig. 10**

Impression of the town of Gragnano at the time of the 1841 mass movement, illustrated by Ranieri

The Gragnano area, approximately 15 km south of Vesuvius, is reported to have received a cover of over 1 m from the 79 A.D. eruption. On 22 January 1841, after a period of exceptional rain during which some 125 mm fell at the Naples station over a 4-day period, four large landslides occurred on the northern slope of Mount Pendolo, at the toe of which the village of Gragnano is situated. An architect at the time (Montella 1841) describes one of these mass movements as having a triangular shape; the apex reaching the middle of the slope of Mount Pendolo. Material disturbed by this mass movement reached the village of Gragnano and caused significant destruction, as recorded by Ranieri (Fig. 10). Gragnano was also affected by an event in August 1935 when again mud invaded part of the village and by a major occurrence on 17 February 1963 when 14 landslides were triggered by the 249 mm rain which fell in a period of 3 days. On this occasion the urban areas of Castello, Aurano, Caprile and S. Nicola were also affected. The newspaper "Corriere di Napoli" describes tongues of mud penetrating deeply into Gragnano village.

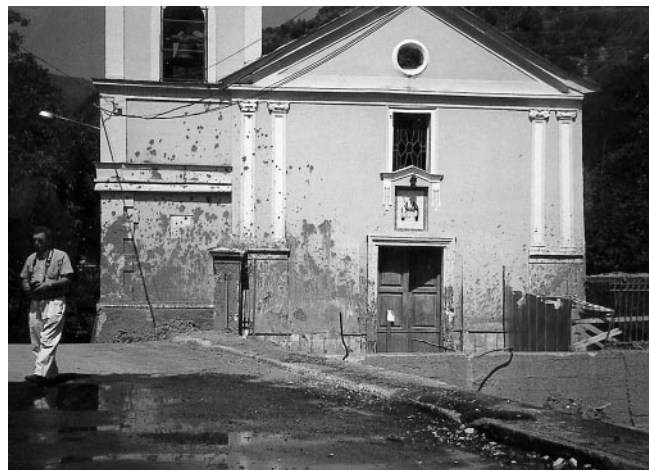
Fig. 12

Mud splattered on walls of S. Pietro church, adjacent to the Bourbon culvert, Quindici

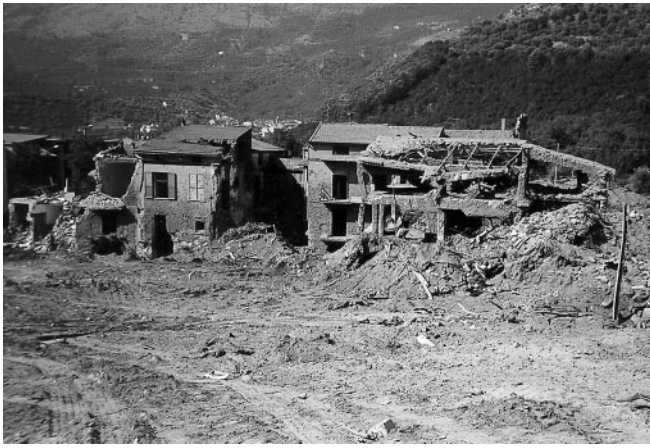
**Fig. 13**

Remains of the building which partly deflected the mass movement; note mud on the roof

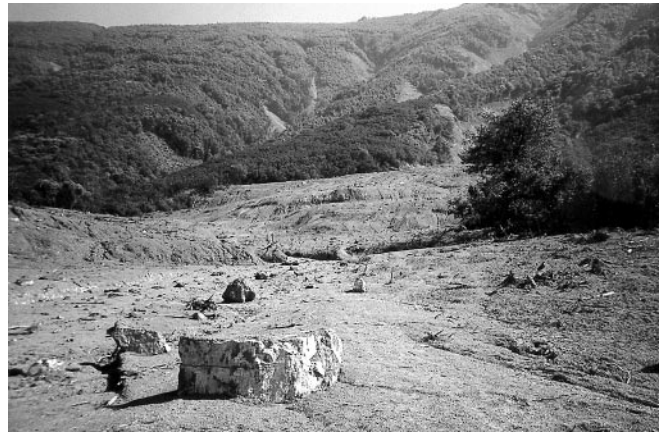
**Fig. 16**

View upslope over the debris from the mass movement showing the occasional limestone boulders

stone boulders up to $0.7 \times 1 \times 2$ m were also present (Fig. 16). Towards the edges of the flow the trees appear to have been pushed aside while the abundant fragments within the main mass indicate they were broken by the activity of the slide itself and by impact with encountered objects.

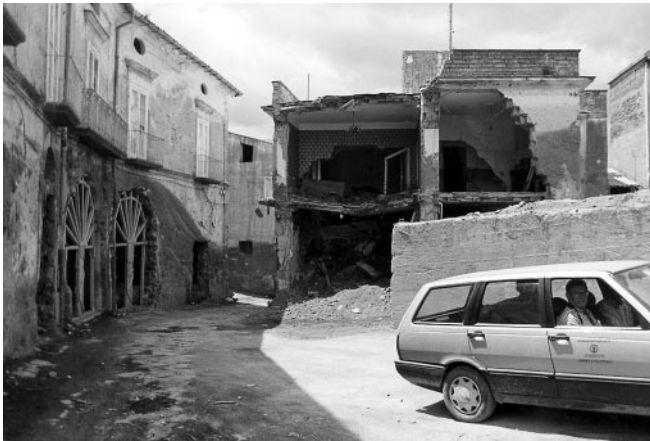
**Fig. 14**

Indication of the damage in Quindici and the line showing the level to which the wave of debris reached

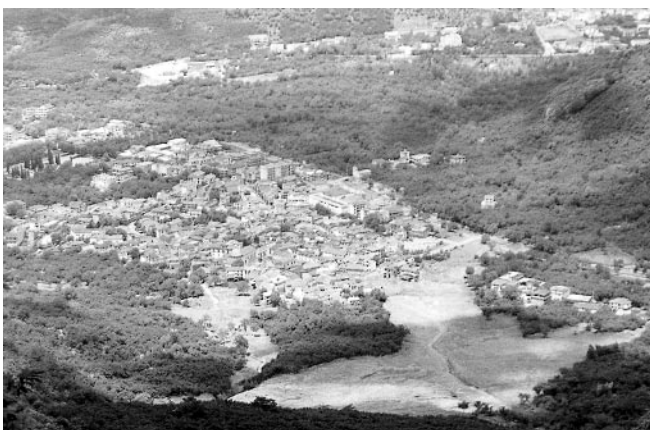
**Fig. 15**

Indication of the extent of the debris which penetrated into the town of Quindici

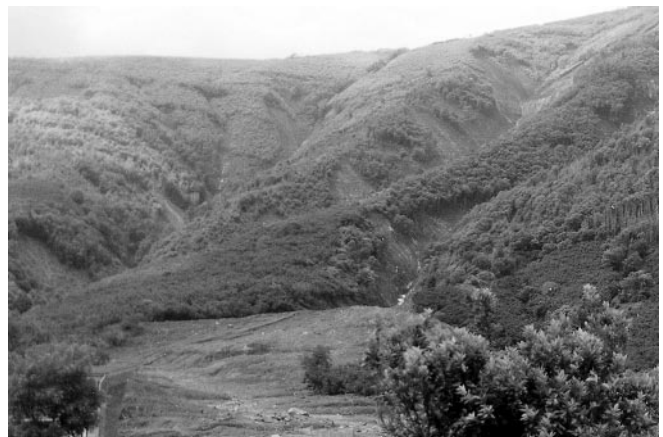
**Fig. 17**

Typical view of the limestone massifs showing the gully failures extending almost to the crest of the hills

As seen in Fig. 17 the top of the gully failure zones is frequently near the crest of the hill. Although in some cases

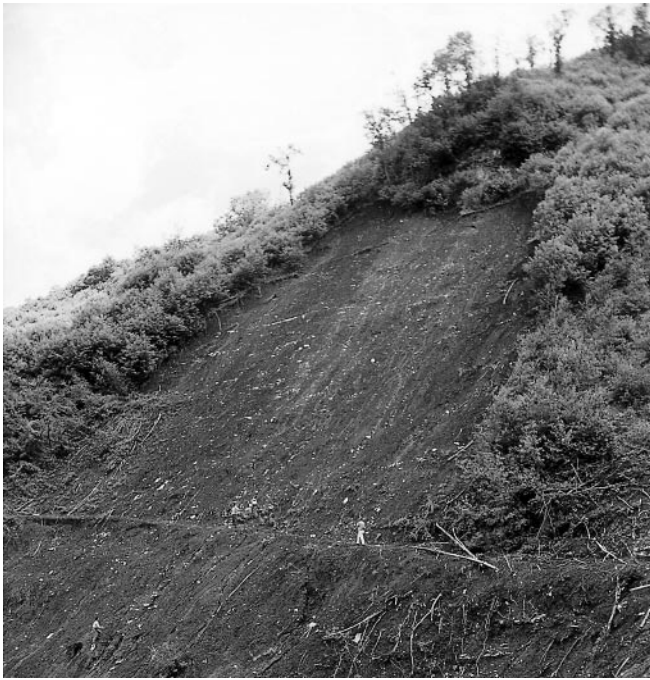
**Fig. 18**

Arcuate feature developed above a trackway

7. The creation of the trackways around the slopes would produce an upslope angle significantly greater than that of the already steep gradient. An increase in water and hence weight in the upslope material would in itself be sufficient to cause mass failure, resulting in an arcuate feature developing above the trackways (Fig. 18). The failed material would then increase the loading on the

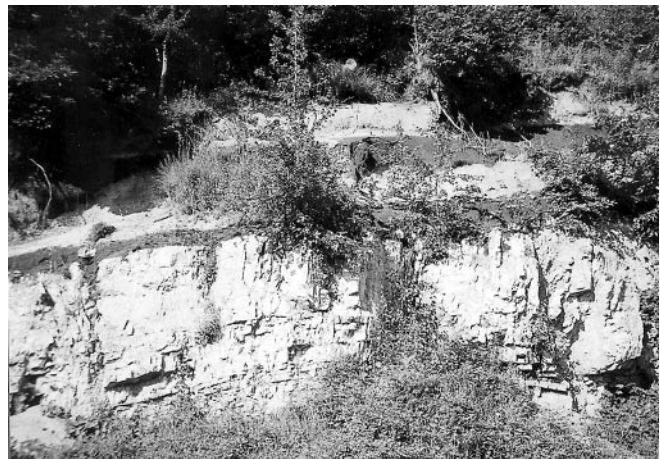
Fig. 21

Uneven nature of the limestone bedrock where thicker pyroclastic deposits accumulated in hollows

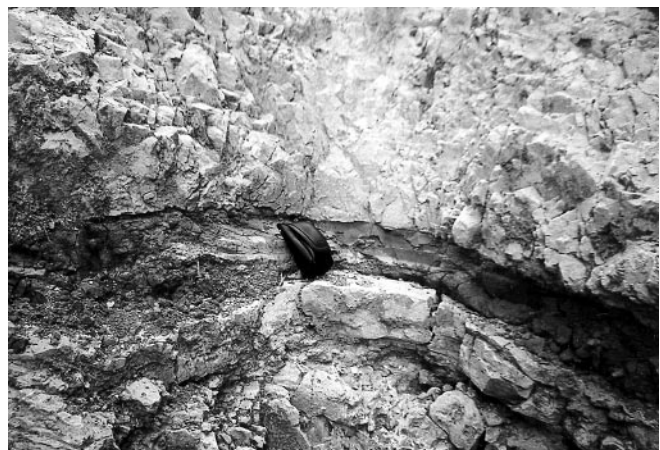
Fig. 22

Impure limestone/mudrock band in the Mesozoic limestones east of Quindici

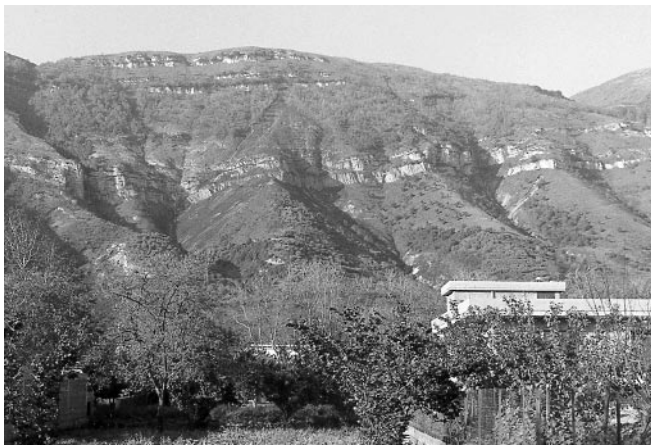
**Fig. 25**

View of the northern side of the P.zo d'Alvano showing outcrops of vertical faces of limestone on a hill slope generally mantled with volcanogenic materials
