Tohoku Chapter, Architectural Institute of Japan  
Reconnaissance Report (11) on Building Damage in Kurihara City  
The 2011 off the Pacific Coast of Tohoku Earthquake  
Released on March 28, 2011

Professor Masato Motosaka, Graduate School of Engineering,  
Tohoku University  
(Translated by Shunsuke Otani, University of Tokyo)

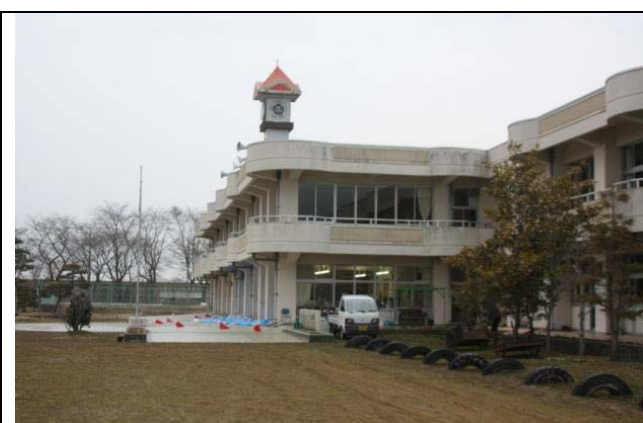
No damage was observed in the two story reinforced concrete Kurihara City Municipal Wakayanagi Elementary School Building, supported by pile foundation. Due to the soil settlement, 20 cm deep opening was observed (Photos 9 and 10). A statute fell down (Photo 11). The school master said “the large motion was felt in the east-west direction. The length of piles was told to be 30 m.” The gateposts of the Kanro-ji temple fell to the west near the school (Photo 12), and a large masonry lantern fell in a similar manner. The dominant frequency of the (H/V) ratio of horizontal to vertical spectra of micro tremor measurements at the Wakayanagi Elementary School after the 2008 Iwate-Miyagi Inland Earthquake was observed to be 0.8 Hz. In the neighborhood of the school, utility poles were tilted (Photo 13), cracking on the road, severe tilting of a timber house (Photo 14) in the second story were observed,

Photo 9: Overall view of Kurihara City Municipal Wakayanagi Elementary School
