Machine diagnosis: Quick and easy through FFT analysis

Vibration spectra of a belt-driven exhaust fan

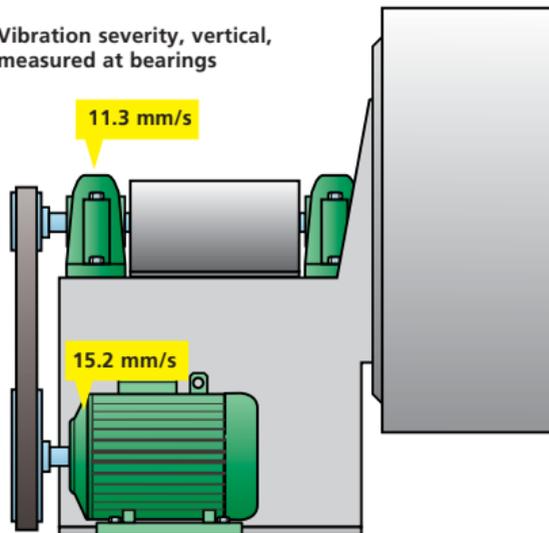
Paint shop exhaust fan (P = 37 kW)

1. Parameter measurement

Vibration severity, vertical,
measured at bearings

Motor: 1475 rpm = 24.58 Hz

Fan: 820 rpm = 13.67 Hz

Let us examine a simple practical example to illustrate the possibilities of vibration analysis: a belt-driven fan unit had failed due to excessive vibration. Since the most severe vibration level was measured on the drive motor, the motor seemed the logical candidate for examination. Vibration analysis showed, however, that the extremely severe vibration (15.2 mm/s) at the motor was occurring primarily at a frequency which was conducted to the motor via the belt drive. When the belt drive wheel on the fan was balanced, vibration decreased to acceptable levels of 2.3 mm/s on the fan and 3.2 mm/s on the drive motor.

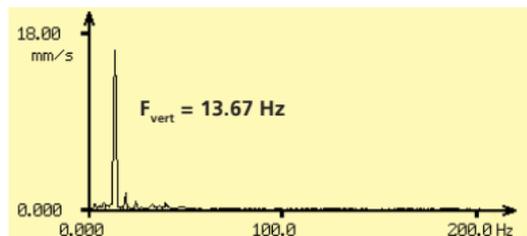
FFT spectrum of vibration signal

Fan bearing, radial/vertical

vibration, the root cause - drive belt wheel unbalance - was made clear by checking the frequency peaks in the FFT vibration spectrum.

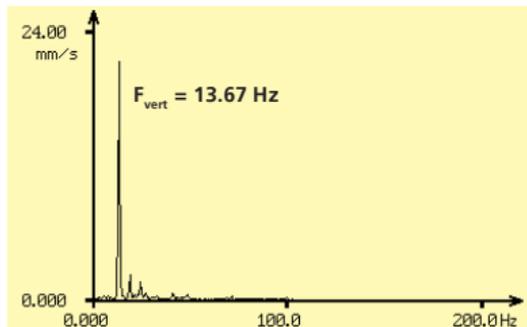
Motor bearing, radial/vertical

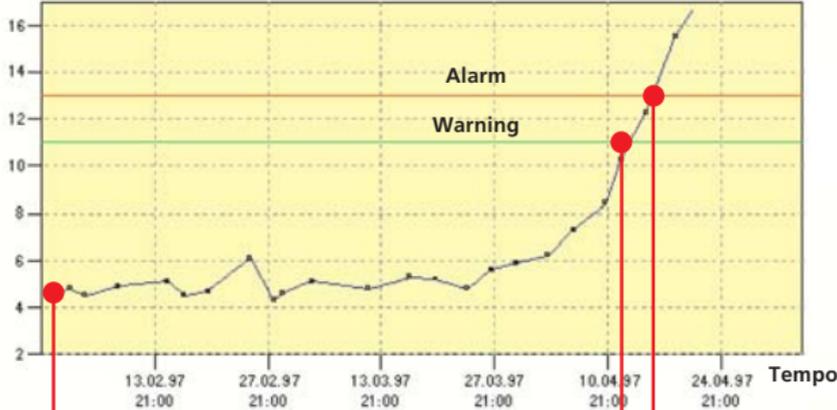
Vibration parameter

- Parameter trend monitoring
- Alarm notification when tolerances are exceeded
- Reference spectra (good condition)
- Manual in-depth diagnosis / on-site analysis

A rational approach to successful and effective condition monitoring is that of trending the development of characteristic overall value measurements of machine condition over time. The trend readings are plotted as shown here and compared with appropriate warning and alarm thresholds. When thresholds are exceeded (and not before then), detailed vibration diagnosis is performed in order to locate the exact source of trouble and to determine the corresponding maintenance remedy. Let us examine, then, the vibration monitoring and diagnosis techniques that hold particular relevance for electric motors.

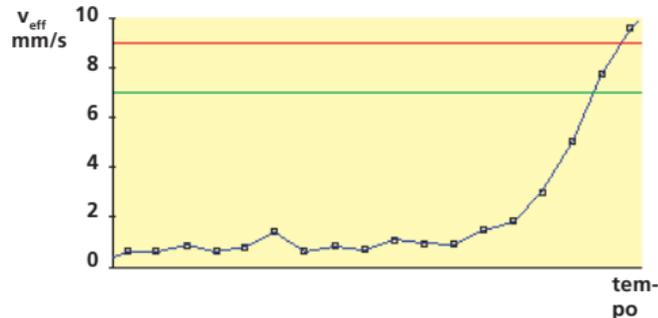
Level 1: Parameter trend monitoring

- Comprehensive
- Long-term
- Less-skilled personnel

Machine monitoring

Vibration load
Bearing condition

Vibration strength, displacement, acceleration
Shock pulse for bearing evaluation
Temperature
RPM
Pump cavitation

Machine condition monitoring calls for measurement of suitable vibration characteristic overall values, which allow the general vibration condition of the machine to be estimated. The trend development of these characteristic overall values points out condition deterioration, i.e. damage progression. This type of overall vibration measurement is characterized as 'Level 1' as shown here. It allows monitoring of many aggregates without imposing high demands in terms of equipment and manpower.

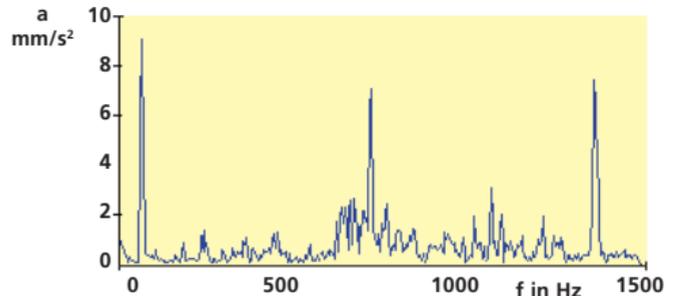
Level 2: Vibration diagnosis following alarm violation

Defect localization via spectrum analysis

Rotor unbalance, shaft misalignment, gear damage, turbulence, field faults, bearing diagnosis etc.

Amplitude spectrum
Envelope spectrum
Time signal
Ordinal analysis
Cepstrum

Characteristic overall value (Level 1) measurements such as these, however, are insufficient for precise localization of defects, as this requires closer analysis of the machine spectrum. Most types of damage can be detected by their characteristic frequencies or typical pattern of frequencies. 'Level 2' vibration

diagnosis normally requires measurement of vibration signals using an FFT vibration analyzer by trained personnel who are experienced in interpreting vibration spectra.

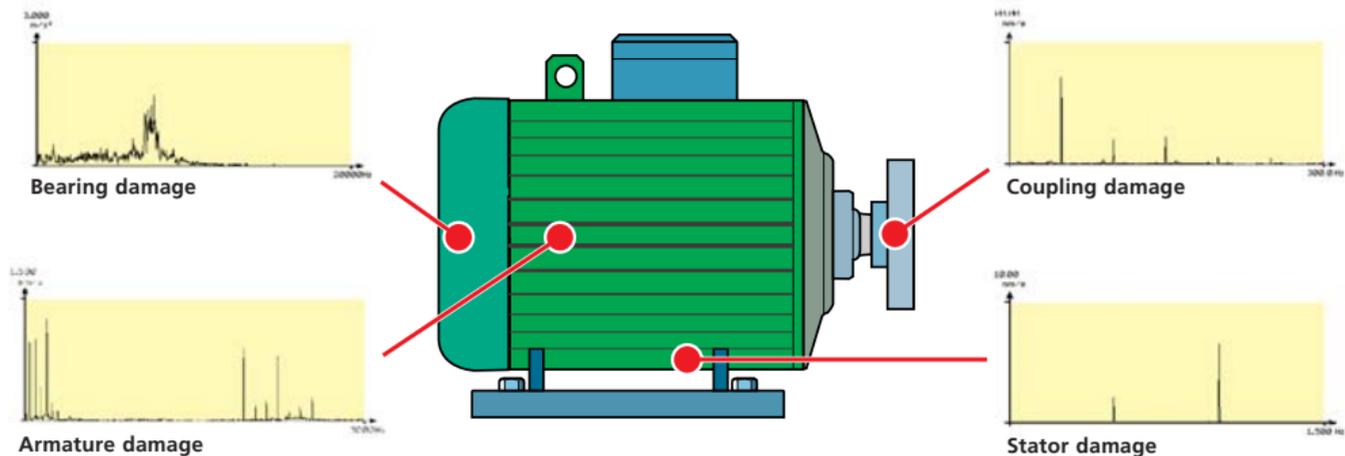
Motor components vulnerable to damage

This illustration gives an overview of the electric motor components most vulnerable to damage. Some types of damage exhibit typical vibration spectra patterns, and each of these phenomena shall now be explained in detail.

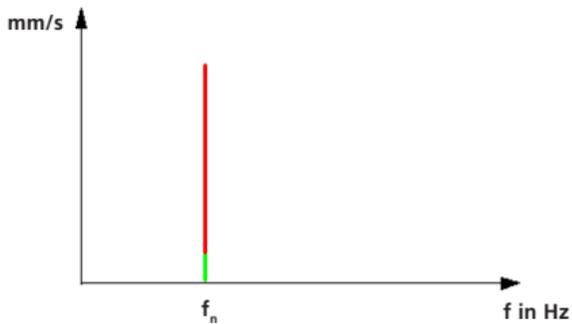
Amplitude of f_n too high

- Rotation frequency $f_n = \text{rpm}/60$
- Evaluation standard: ISO 2372, ISO/DIS 10816-3

Unbalance is understood to be an eccentric distribution of rotor mass. When an unbalanced rotor begins to rotate, the resulting rotating centrifugal force produces additional forces on bearings and rotor vibration at the exact frequency of rotation. This characterizes the spectrum of an unbalanced machine, i.e. the rotation frequency appears as a 'peak' with elevated amplitude, and this can significantly degrade the overall vibration condition of the machine. The necessary redistribution of rotor mass is achieved by balancing the motor rotor either with a balancing machine following disassembly or on-site using a vibration-based balancing instrument. Reference #3 indicates acceptable residual unbalance for rigid rotors.

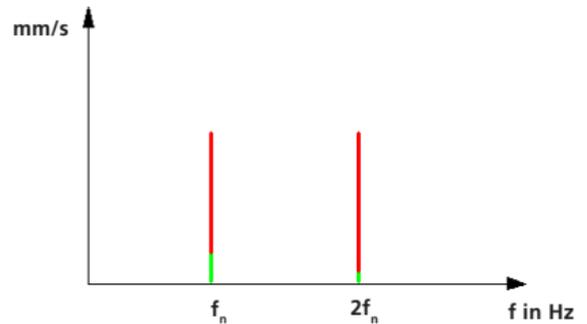
Twice (2x) rotation frequency $2f_n$

- Radial: radial misalignment
- Axial: axial misalignment

Shaft misalignment of directly coupled machines results primarily in elevated vibration at

twice the shaft rotation frequency, sometimes with the peak at shaft rotation frequency elevated as well. If the radial misalignment (i.e. shaft offset) dominates, then this peak is most pronounced for measurements taken in radial direction (perpendicular to the shafts). If angular misalignment (coupling gap) is predominant, then vibration elevation will be most noticeable in frequency spectra of axial measurements. Many manufacturers and operators of electric machines have adopted the use of modern laser-optical shaft alignment systems such as OPTALIGN® to correct excessive shaft misalignment. Recommended alignment tolerances are outlined in Note #4.

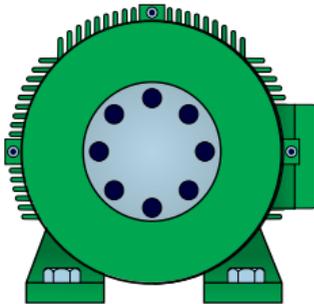
Stator field asymmetry

- Core burnout, short circuit
- Eccentric armature position
- Asymmetric power feed
- Asymmetric winding

Field asymmetry of electric motors can be caused by stator or rotor (armature) defects. The most common faults are

- Motor core short circuiting from armature rubbing or burnout
- Asymmetrical winding
- Asymmetrical power feed and
- Eccentric armature position.

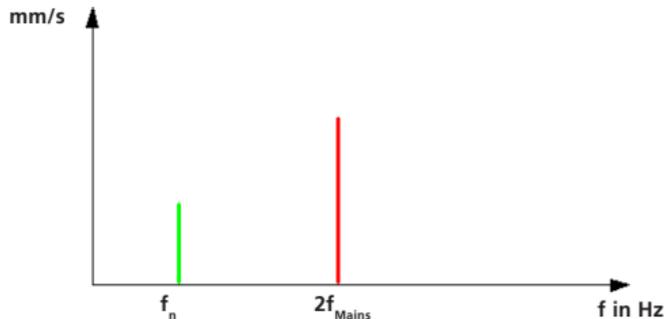
Twice mains frequency $2f_{\text{Mains}}$ visible

Mains frequency $f_{\text{Mains}} = 50$ or 60 Hz

Exception: rectifier drives

Stator field defects can be recognized in the vibration spectrum as peaks occurring at twice the mains frequency, without sidebands.

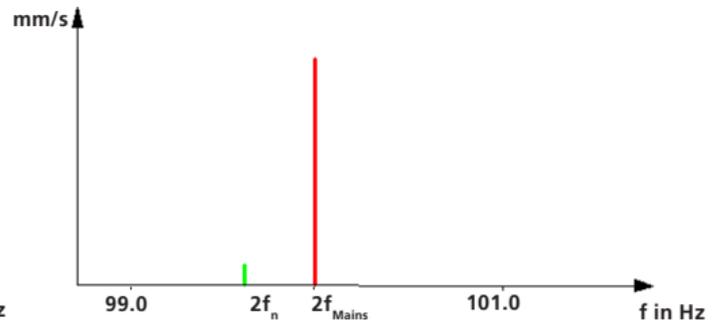
No sidebands visible around $2f_{\text{Mains}}$

2-pole machines:

2x rotation frequency lies just below $2f_{\text{Mains}}$

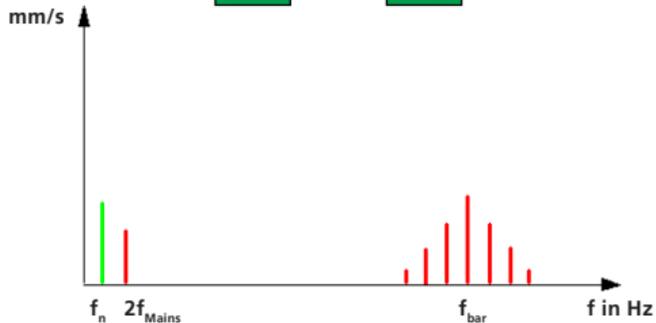
Armature field fault

Bar passing frequency f_{bar} with sidebands visible at $2f_{\text{Mains}}$ intervals

Bar passing frequency $f_{\text{bar}} = f_n \times n_{\text{bar}}$ with rotation frequency f_n and n_{bar} = number of armature bars

- Bar passing frequency with sidebands at twice the mains frequency and
- Mains frequency with sidebands at slipping frequency.

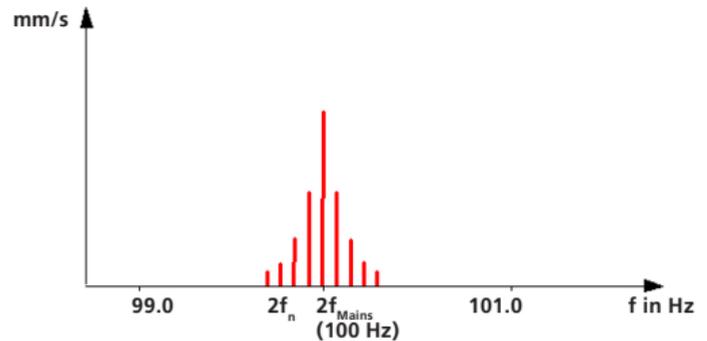
Sidebands visible around $2f_{\text{Mains}}$ at f_{slip} intervals with slip frequency $f_{\text{slip}} = 2f_{\text{Mains}}/p - f_n$ and p = number of stator poles

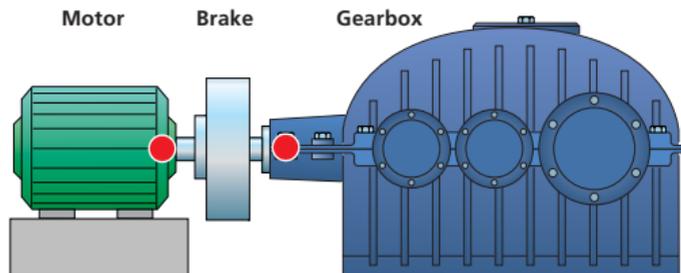
Belt conveyor gearbox

P = 600 kW

n = 996 rpm ($f_n = 16.6$ Hz)

Cause: Brake disk unbalance

The vibration spectrum exhibits a typical unbalance pattern. The levels of vibration severity measured at several locations on the machine point indicate that the source of excitation lies near the coupling. Simple rotor balancing of the brake disk reduced motor vibration to 3.5 mm/s and gearbox vibration to 3.1 mm/s.

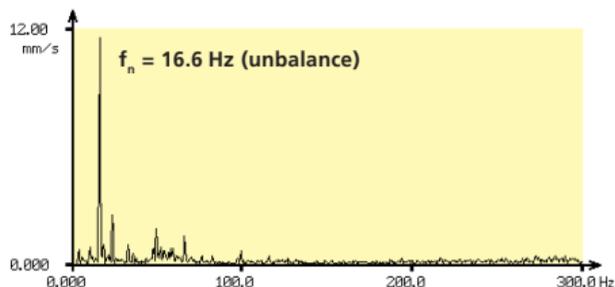
Gearbox, inboard bearing, vertical

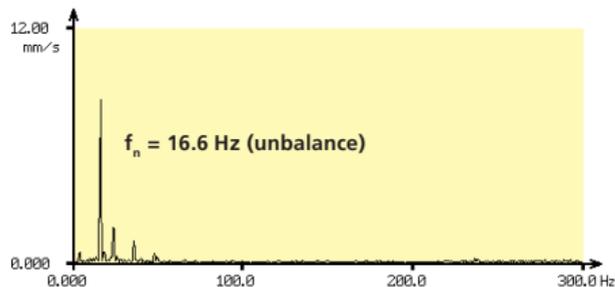
Gearbox, inboard bearing, axial

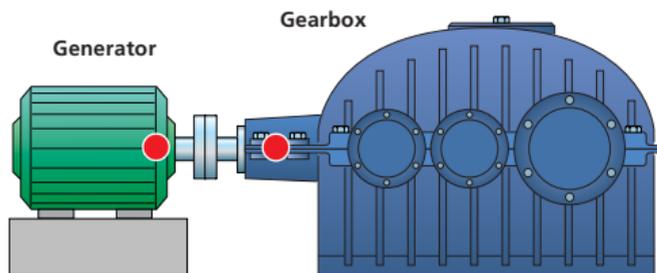
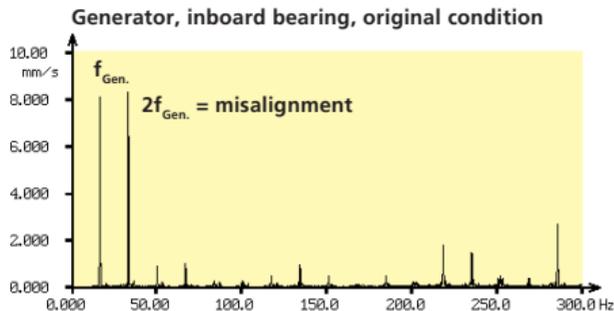
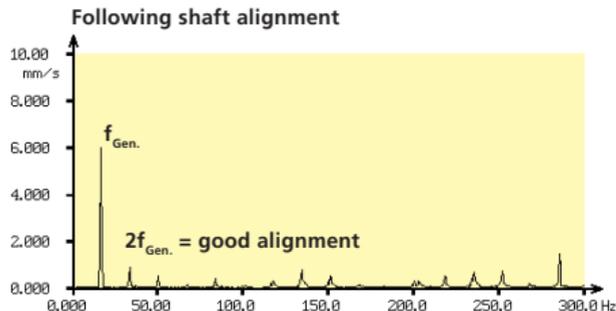
Practical vibration diagnosis: Shaft misalignment

Hydroturbine generator

Before	After
Angularity ($\varnothing = 170$ mm)	0.42 mm	- 0.02 mm
Offset	0.44 mm	0.05 mm

Cause: Shaft misalignment

The vibration spectrum shows a distinct peak at twice the shaft rotation frequency, which clearly indicates shaft misalignment. Following shaft alignment, the peak has disappeared, but the rotor unbalance evident in the previous spectrum remains to be corrected.

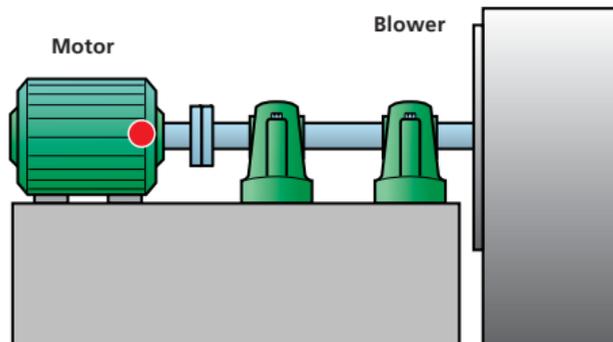
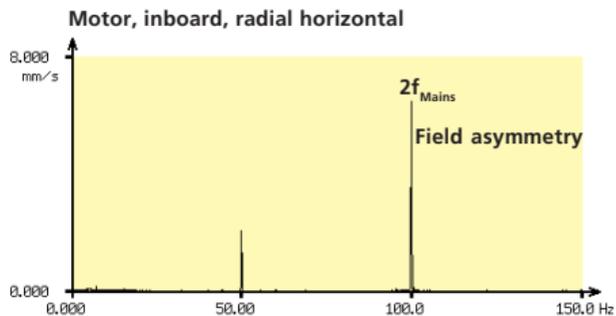
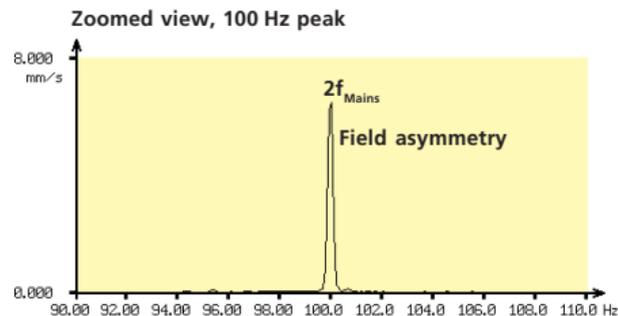
Motor inboard, RH 4.8 mm/s

Cause: Stator core burnout

The motor had drawn attention due to elevated vibration which also occurred with the coupling removed. The unusually high peak at twice the line frequency pointed toward stator damage. Disassembly revealed that the stator packet had burned out due to local short circuiting of the core. The motor had to be completely replaced.

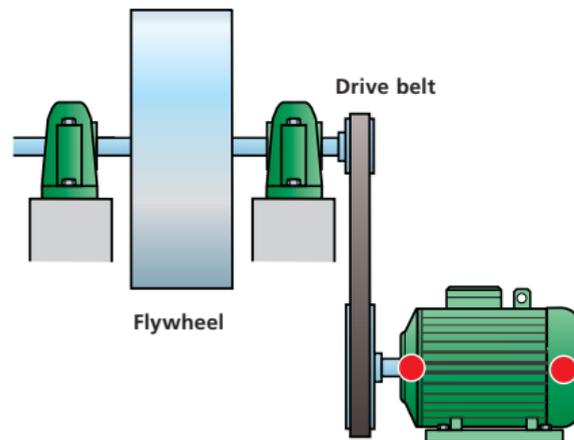
Practical vibration diagnosis: Loose belt drive wheel

Motor outboard 7.1 mm/s

Cause: Excessive play in motor shaft
belt drive wheel

A press drive motor had developed severe vibration and was producing unusual noises that had become more pronounced from one day to the next. In stark contrast to the usual vibration spectrum, the rotation frequency was hardly visible at all, but multiples of the rotation frequency were quite obvious. These symptoms remained unchanged when the drive belt was removed from the motor. The source was found to be loose mounting of the belt drive wheel on the motor shaft. The problem was resolved by remachining the motor shaft and reattaching the belt drive wheel.

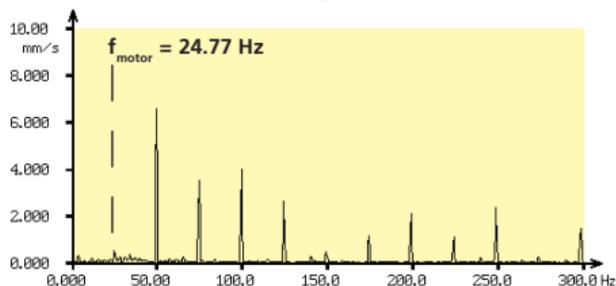
Motor inboard, before repair

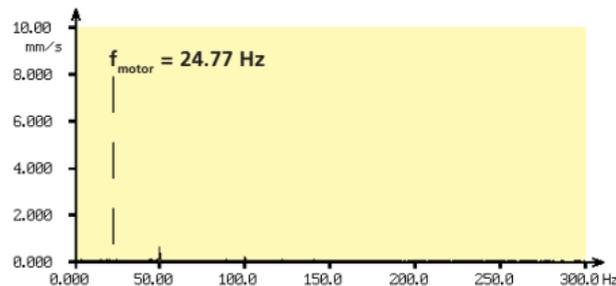
Following repair

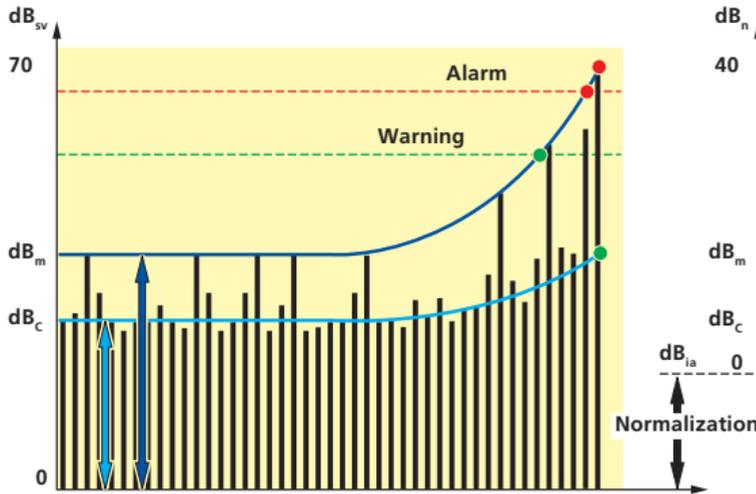
Non-normalized measurement

Shock pulse peak value dB_m and carpet value dB_c as absolute level in dB_{sv}

- Threshold (limit) values set individually for every single location

This illustration shows the normalization procedure that PRÜFTECHNIK instruments use during shock pulse measurement to compensate the influence of rolling velocity differences. The initial level, and in turn the adjusted initial value dB_{ia} , are determined by taking a comparative measurement in good condition. This serves as the reference for relative level measurement of maximum shock pulse value dB_m and the shock pulse carpet value dB_c . This procedure allows measurements from different bearings to be compared using the same level scale so that tolerances do not have to be set individually for every single measurement location.

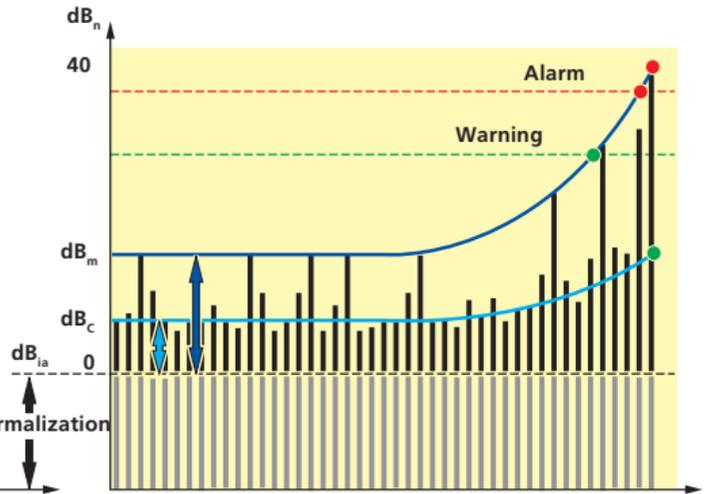
Normalized measurement

Shock pulse max. value dB_m and carpet value dB_c as relative level in dB_{sv} referenced to dB_{ia} value

- dB_{ia} value includes influence factors such as rolling velocity, signal damping, bearing load
- Different threshold limits are linked to the setup dB_{ia} value; the same predefined threshold values are used for all locations

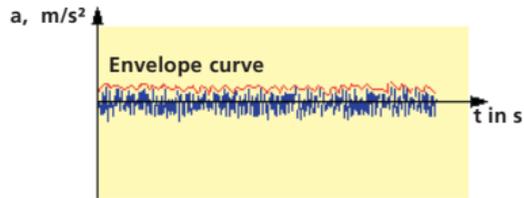
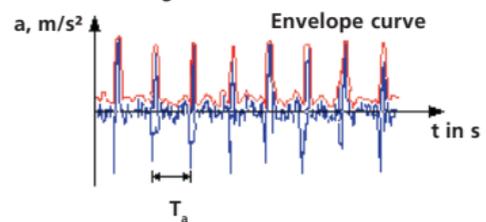
Time signal

The illustrations here explain the envelope analysis procedure, which begins with filtering out the appropriate range of frequencies that contain the signal emitted by the bearing during operation. This signal component is examined for the pulses that arise when bearing elements roll over damaged locations. Demodulation is used to calculate a curve that 'envelops' the bearing signal. If the time interval between periodically-occurring peaks in the envelope curve match one of the critical frequencies characteristic of bearing damage, then the corresponding bearing component can be assumed to be damaged.

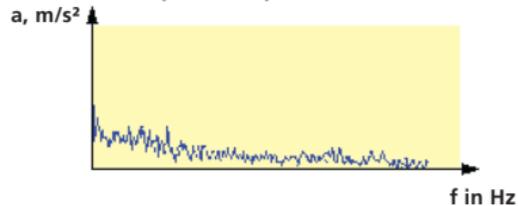
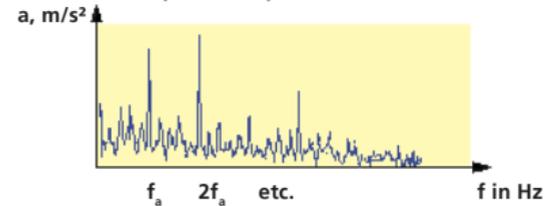
Envelope curve spectrum

Damage frequency $f_a = 1/T_a$

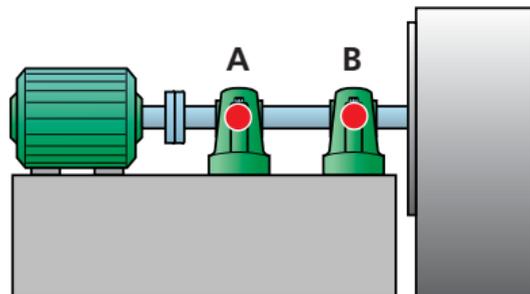
Cause: Severe inner race damage on inboard bearing

This shows an example of advanced damage to the inner race. The great increase in shock pulse levels, especially that of peak value dB_m from 18 to 48 dBsv, signified serious bearing damage. Envelope spectrum analysis indicated a pattern typical of inner race damage, which was then confirmed following bearing replacement: one of the two races of the inner ring already exhibited a damaged surface area of about 15 x 15 mm / 5/8" x 5/8".

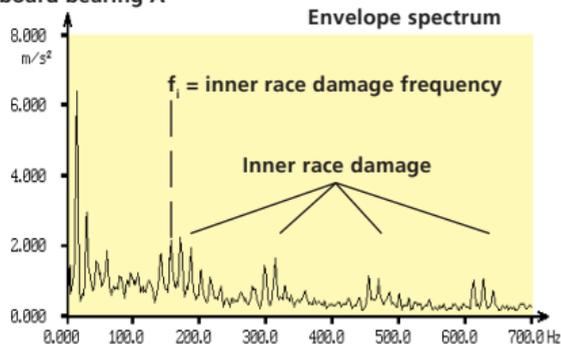
Inboard bearing A

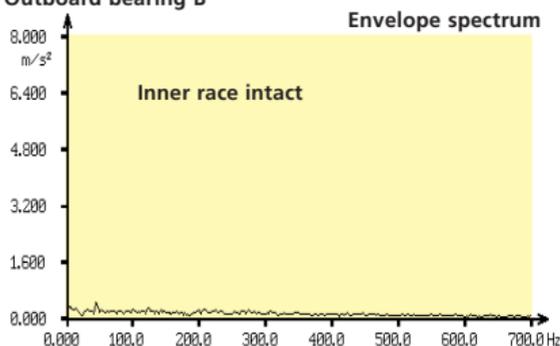
Outboard bearing B
