# COSTRUZIONI NAVALI II

**(materiali compositi: dettagli costruttivi)**

# Guidance Notes for the Classification of Special Service Craft

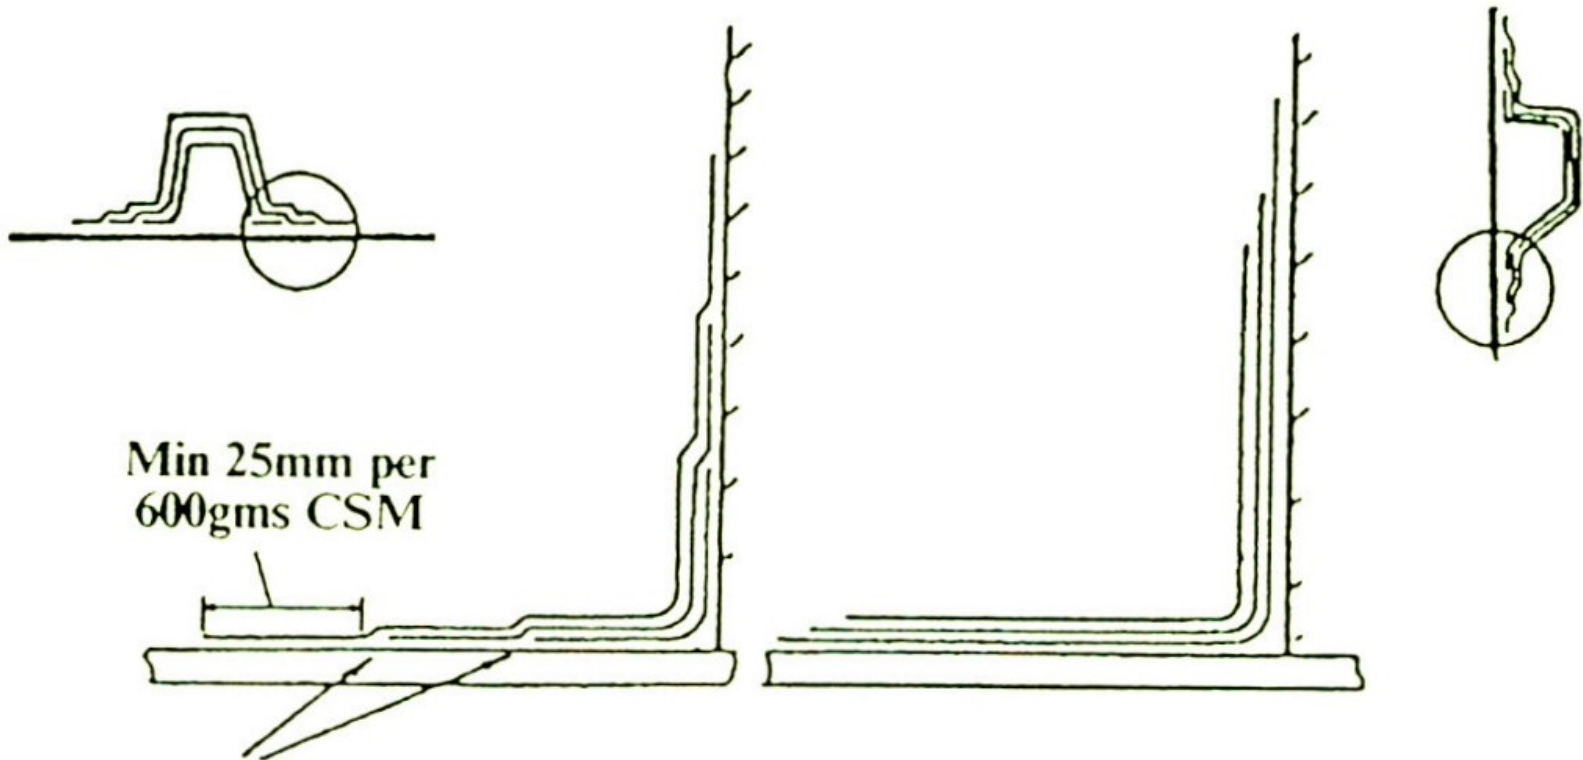
## Flange laminations

These interruptions “perform”  
a crack arrestor function  
should the flange begin to  
fail

Once this flange begins to debond  
it is able to continue unabated

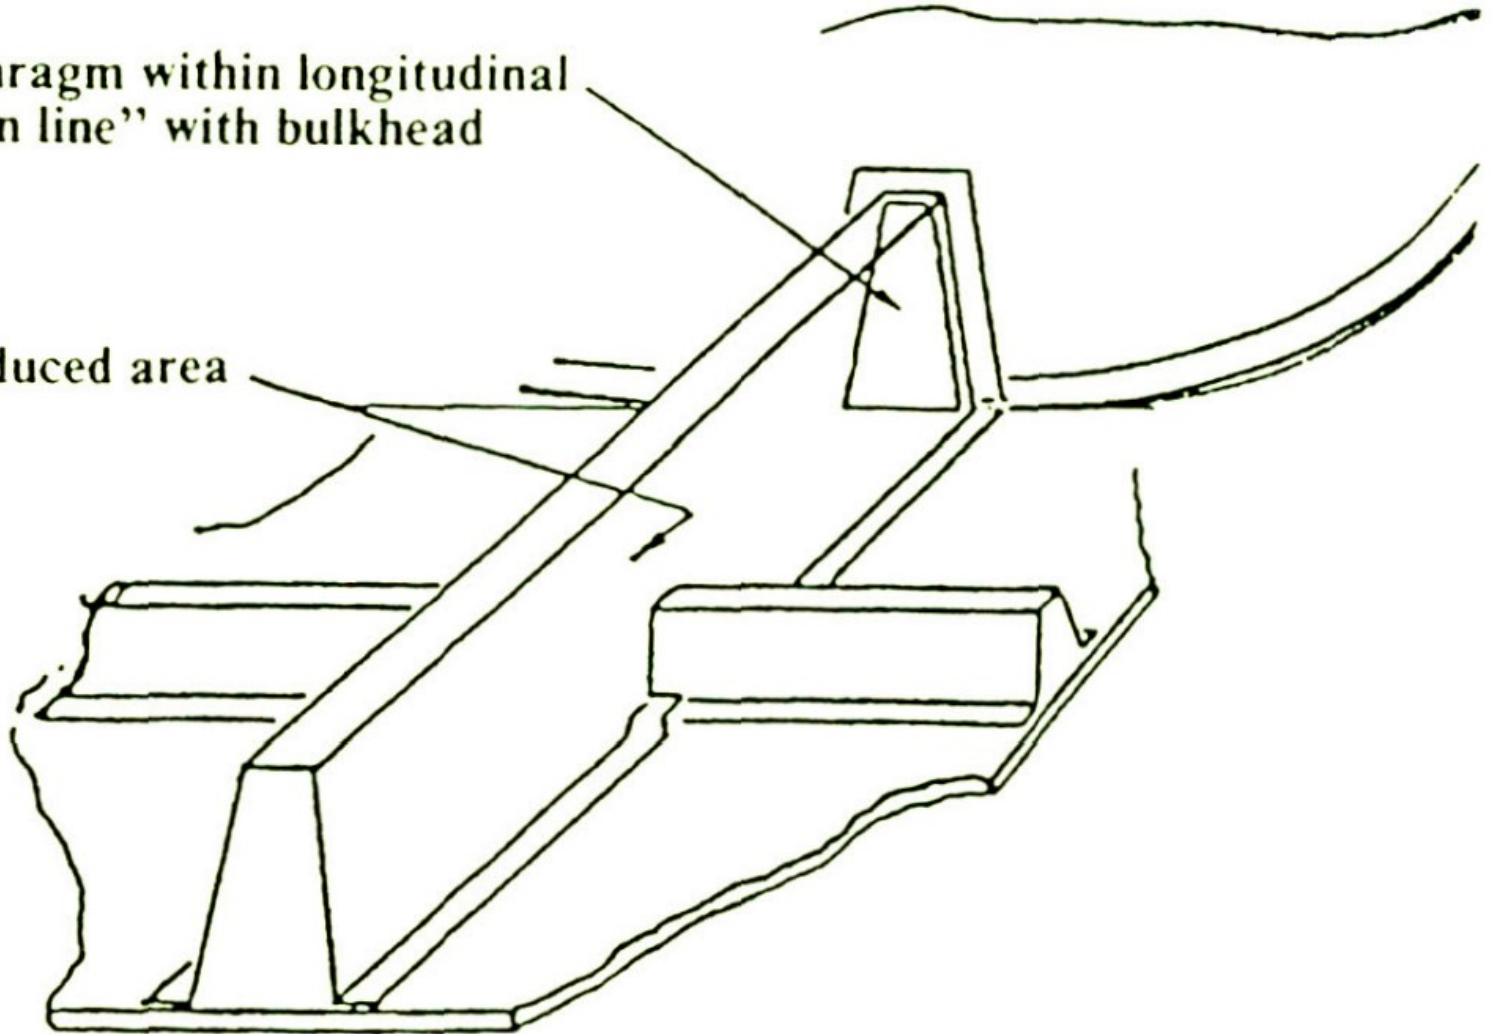
## Intersection of frame/main longitudinal

Diaphragm within longitudinal  
"in line" with bulkhead

Reduced area

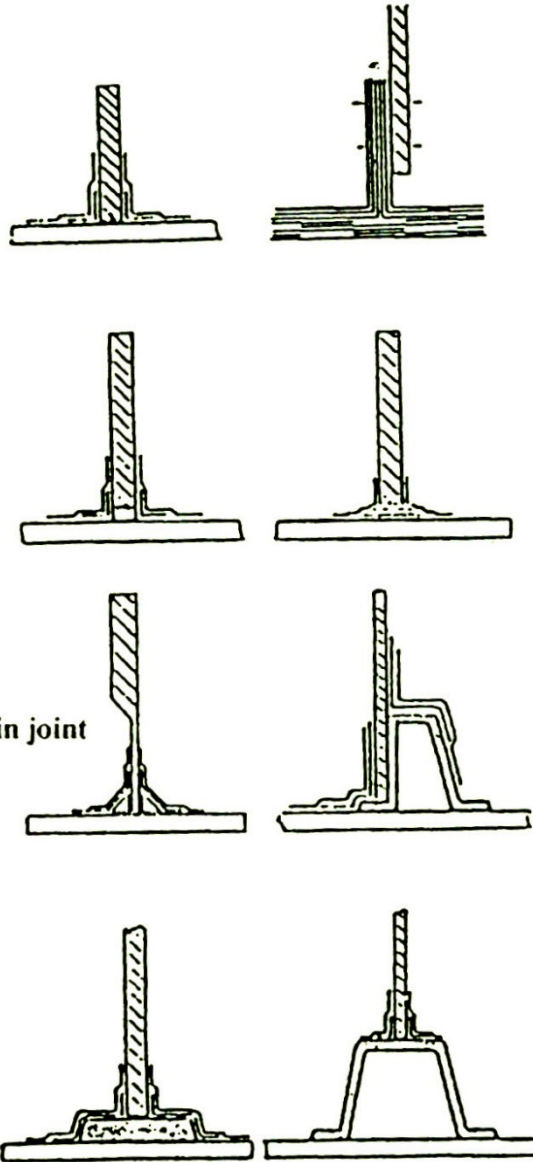
**Various bulkhead securing arrangements**

Pin joint

**Preferred — those providing support and spreading load**

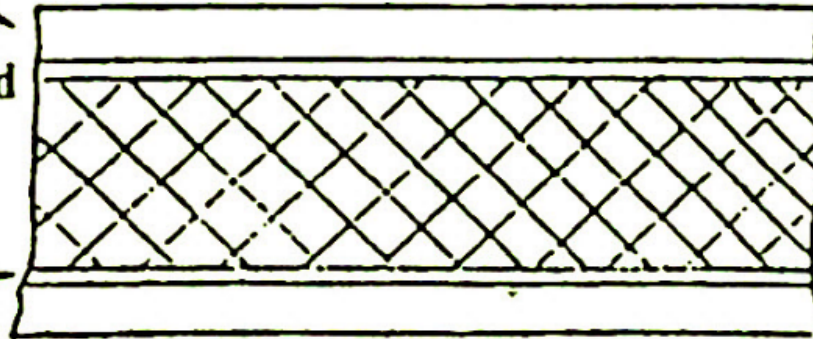
## Sandwich variables

Laminate — thickness  
— make-up  
— lay-up standard

Core — materials  
— density  
— thickness

Skin/core bond — process  
— resin  
— surface treatment

The bond — usual made with laminating resin + interface ply — mat layer

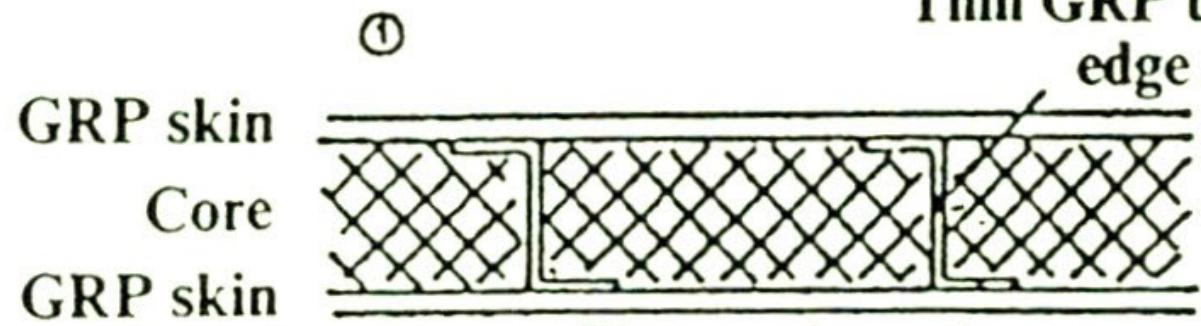
# Shear web

Thin GRP usually laminated on edge of core block

Shear webs — transverse and/or longitudinal

② Large bond areas to ③

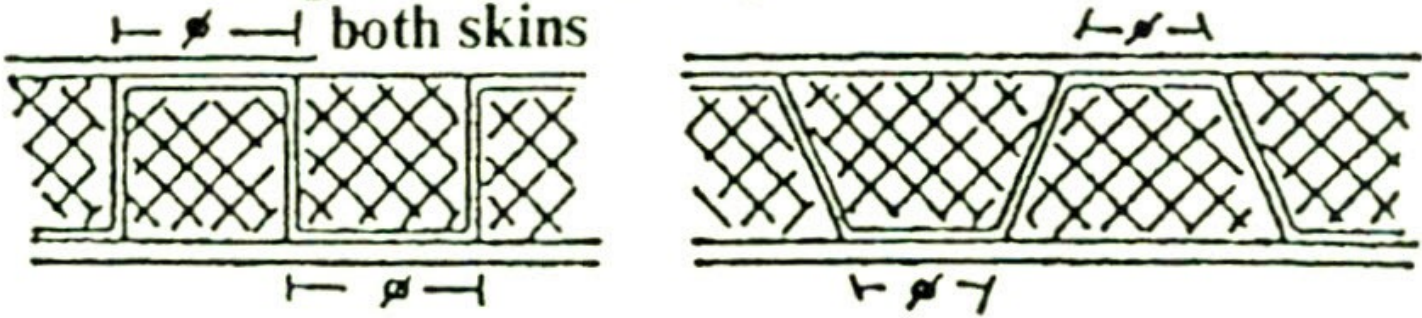
Shear web alternatives  
uni-directional  
(construction complications)

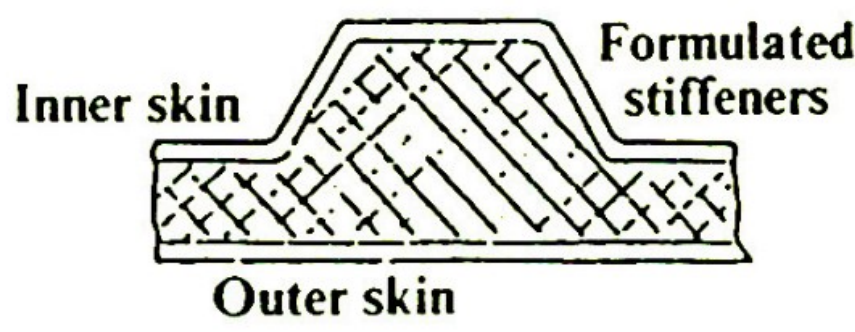
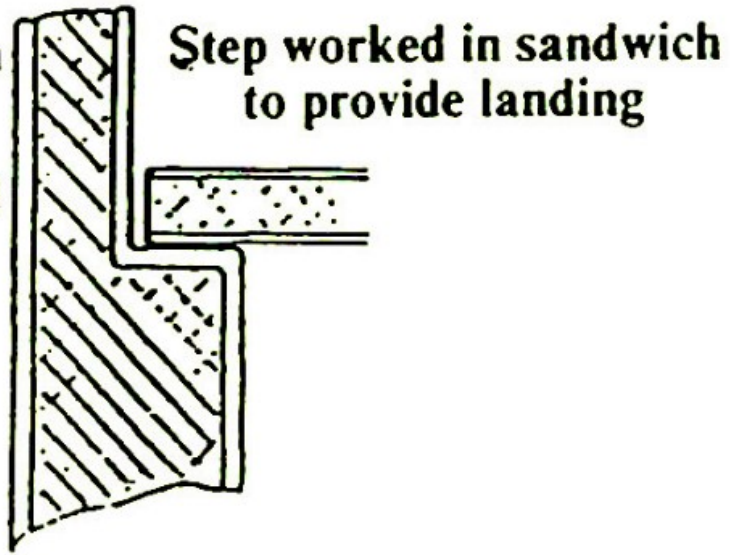
Joggled skin sandwich

not usual

But often

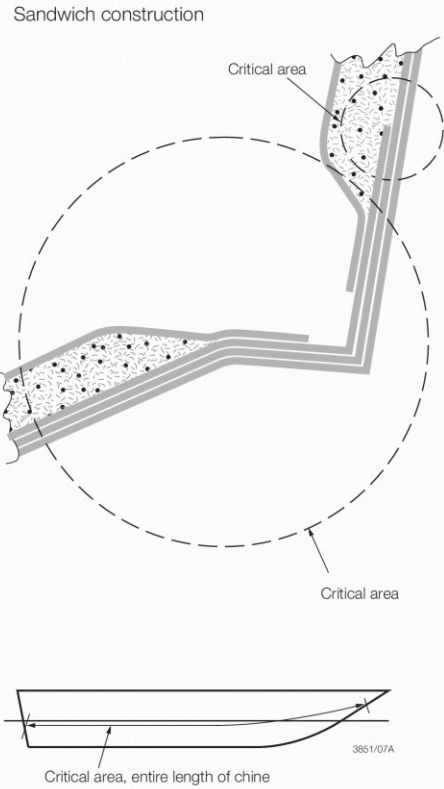
CRITICAL AREAS

DETAIL DESIGN IMPROVEMENT

- Failure Mechanism Excess loads due to grounding, docking, slinging, hydrodynamic and other types of impact.
- Building Tolerance All FRP materials to comply with the Rules for Special Service Craft.
- Laminating Requirements To be in accordance with Part 8 of the Rules for Special Service Craft.

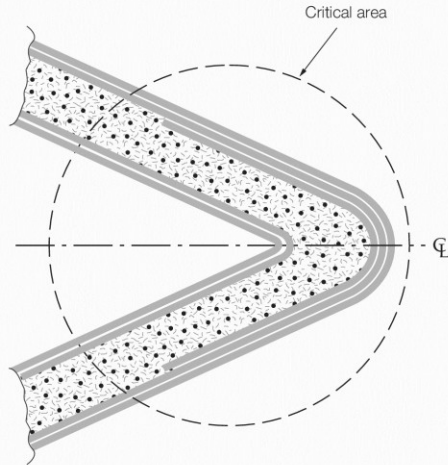
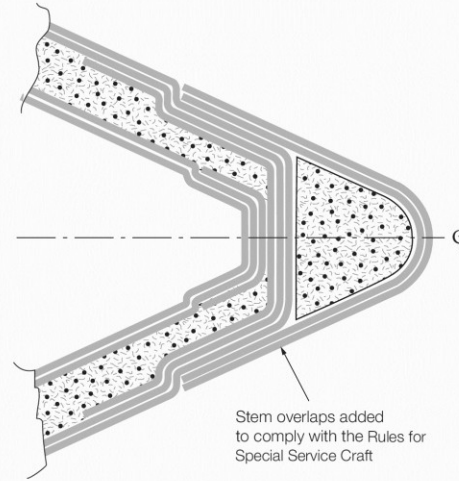
DETAIL DESIGN IMPROVEMENT

Sandwich construction

- Failure Mechanism            Excess loads due to collision and impact with floating debris.
- Building Tolerance            All FRP materials to comply with the Rules for Special Service Craft.
- Laminating Requirements    To be in accordance with Part 8 of the Rules for Special Service Craft.

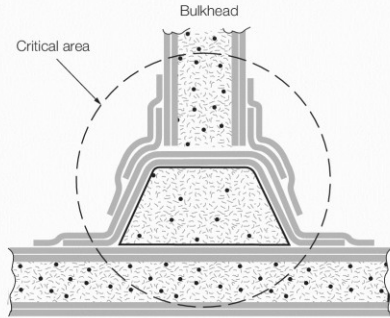
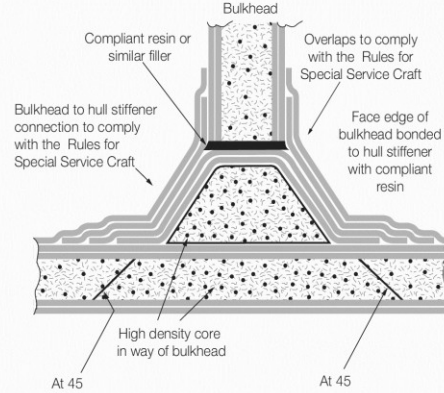
DETAIL DESIGN IMPROVEMENT

Sandwich construction, high speed

All bulkhead hull connections to comply with the Rules for Special Service Craft

- Failure Mechanism      Crushing of the sandwich core under the bulkhead, and delamination of the sandwich bulkhead due to excess loads arising from berthing, slinging, impact and racking.
- Building Tolerance      All FRP material to comply with the Rules for Special Service Craft.
- Laminating Requirements      To be in accordance with Part 8 of the Rules for Special Service Craft.

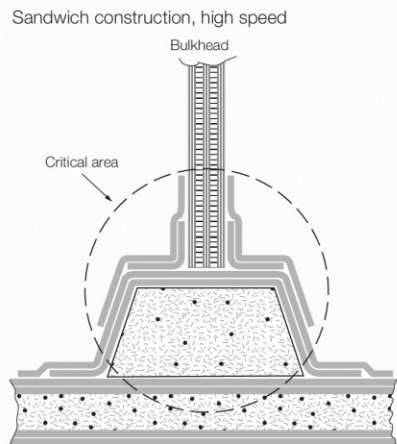
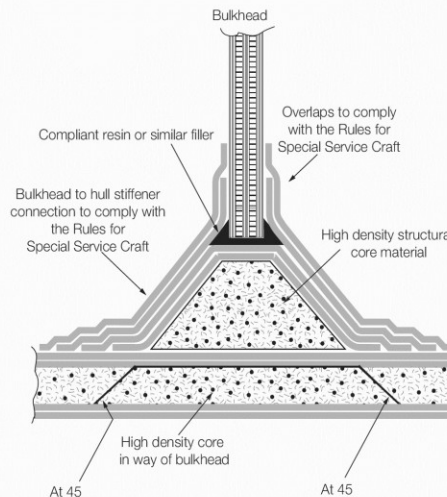
CRITICAL AREAS

DETAIL DESIGN IMPROVEMENT

All bulkhead hull connections to comply with the Rules for Special Service Craft

- Failure Mechanism      Crushing of the sandwich core under the bulkhead due to excess loads arising from berthing, slinging, impact and racking.
- Building Tolerance      All FRP material to comply with the Rules for Special Service Craft.
- Laminating Requirements    To be in accordance with Part 8 of the Rules for Special Service Craft.

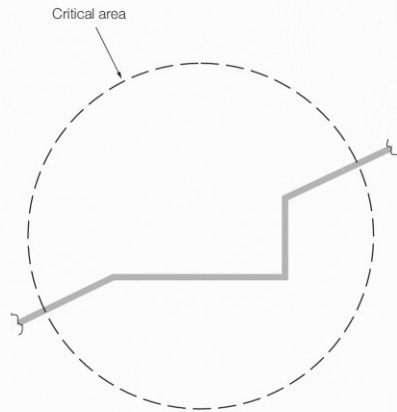
CRITICAL AREAS

Single skin construction

- Failure Mechanism Excess loads due to grounding and impact.
- Building Tolerance All FRP material to comply with the Rules for Special Service Craft.
- Laminating Requirements To be in accordance with Part 8 of the Rules for Special Service Craft.

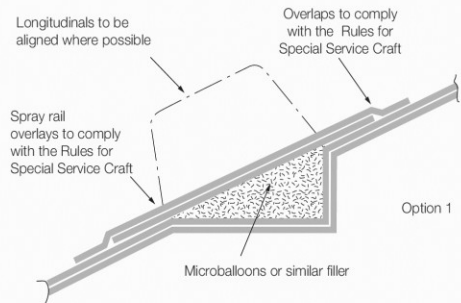
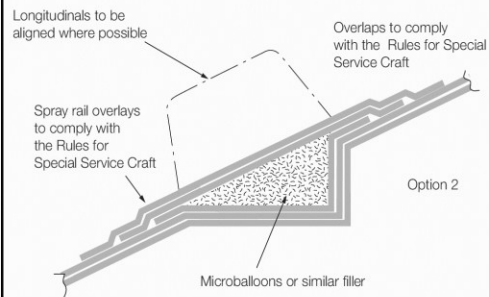
DETAIL DESIGN IMPROVEMENT

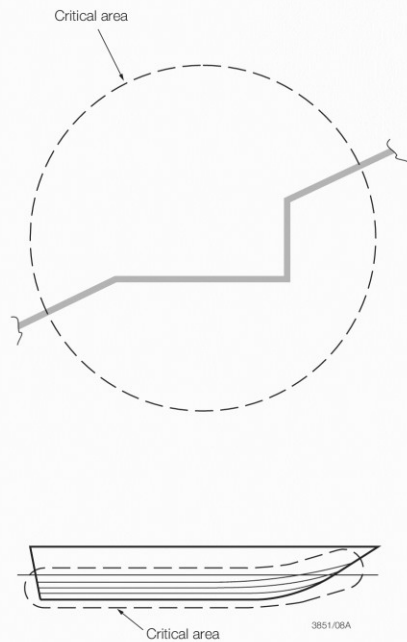
Single skin construction

AREA: Hull structure

ITEM: Spray rails

CRITICAL AREAS

Failure Mechanism Excess loads due to grounding and impact.

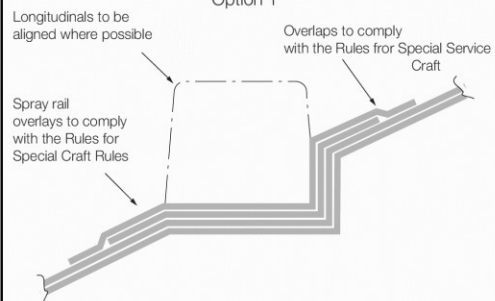
Option 1

DETAIL DESIGN IMPROVEMENT

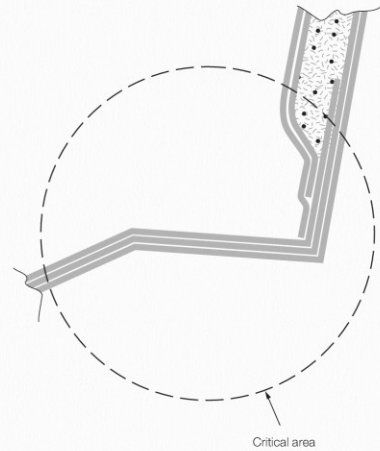
Sandwich side and single skin bottom

AREA: Chine in way of side shell and bottom shell connection

ITEM: Chine reinforcement

CRITICAL AREAS

- Failure Mechanism Excess loads due to grounding, docking, slinging and hydrodynamic impact.
- Building Tolerance All FRP material to comply with the Rules for Special Service Craft
- Laminating Requirements To be in accordance with the Part 8 of the Rules for Special Service Craft.

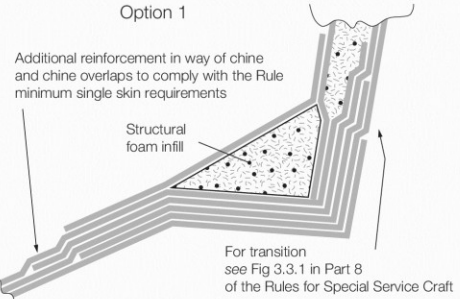
Option 1

DETAIL DESIGN IMPROVEMENT

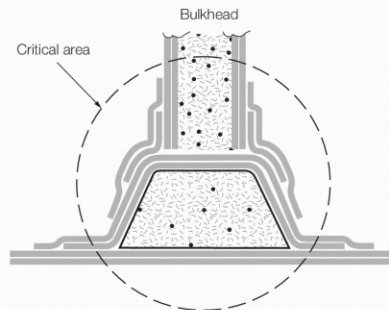
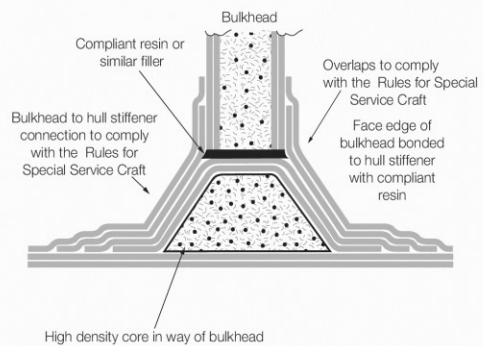
Single skin construction, high speed

AREA: Hull internal structure  
 ITEM: Bulkhead to hull connection

CRITICAL AREAS

DETAIL DESIGN IMPROVEMENT

All bulkhead hull connections to comply with the Rules for Special Service Craft

- Failure Mechanism            Excess loads due to berthing, slinging, impact and racking.
- Building Tolerance            All FRP material to comply with the Rules for Special Service Craft.
- Laminating Requirements    To be in accordance with the Part 8 of the Rules for Special Service Craft.

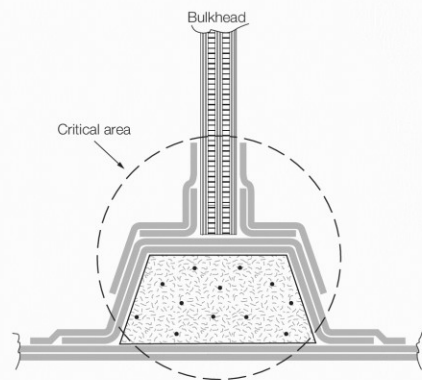
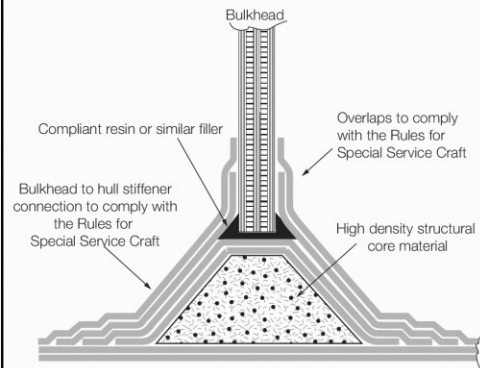
Single skin construction, high speed

AREA: Hull internal structure  
 ITEM: Bulkhead to hull connection

CRITICAL AREAS

DETAIL DESIGN IMPROVEMENT

All bulkhead to hull connections to comply with the Rules for Special Service Craft

- Failure Mechanism            Excess loads due to berthing, slinging, impact and racking.
- Building Tolerance            All FRP material to comply with the Rules for Special Service Craft.
- Laminating Requirements    To be in accordance with Part 8 of the Rules for Special Service Craft.

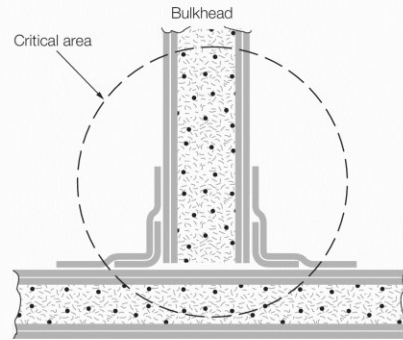
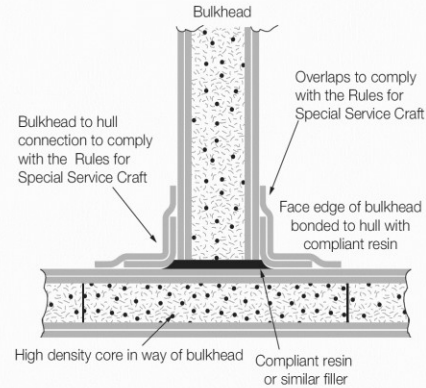
Sandwich construction, low speed

AREA: Hull internal structure  
 ITEM: Bulkhead to hull connection

| Failure Mechanism | Crushing of the sandwich core under the bulkhead, and delamination of the sandwich bulkhead due to excess loads arising from berthing, slinging, impact and racking. |

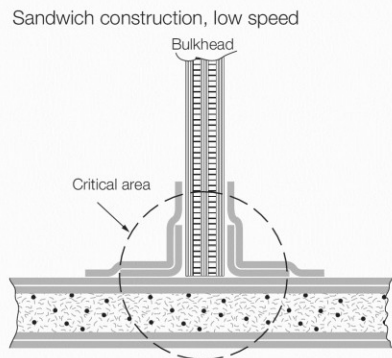
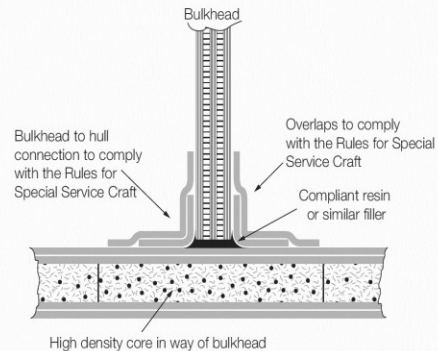
AREA: Hull internal structure  
 ITEM: Bulkhead to hull connection

| Failure Mechanism | Crushing of the sandwich core under the bulkhead due to excess loads arising from berthing, slinging, impact and racking. |

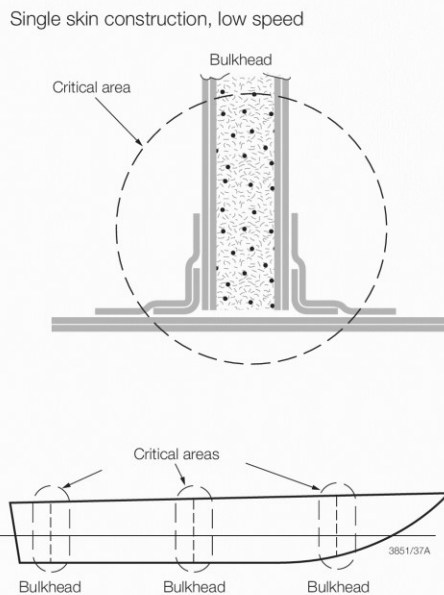
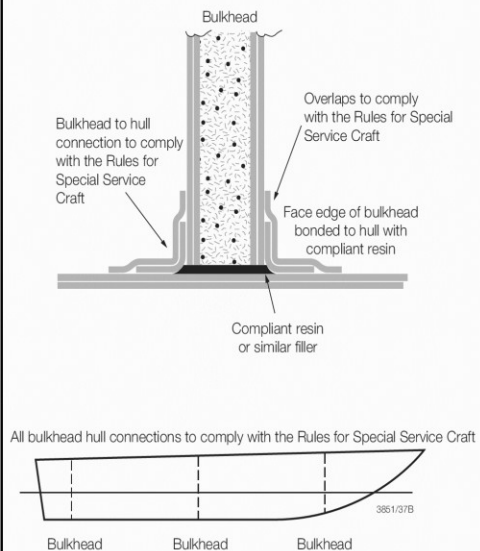
AREA: Hull bottom structure  
 ITEM: Bulkhead to hull connection

| Failure Mechanism | Excess loads due to berthing, slinging, impact and racking. |

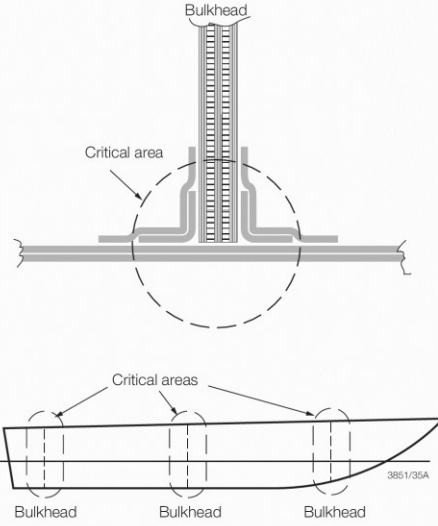
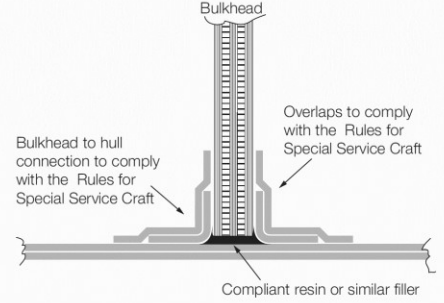
Single skin construction, low speed

AREA: Hull bottom structure  
 ITEM: Bulkhead to hull connection

- Failure Mechanism      Excess loads due to berthing, slinging, impact and racking.
- Building Tolerance      All FRP material to comply with the Rules for Special Service Craft.
- Laminating Requirements    To be in accordance with Part 8 of the Rules for Special Service Craft.

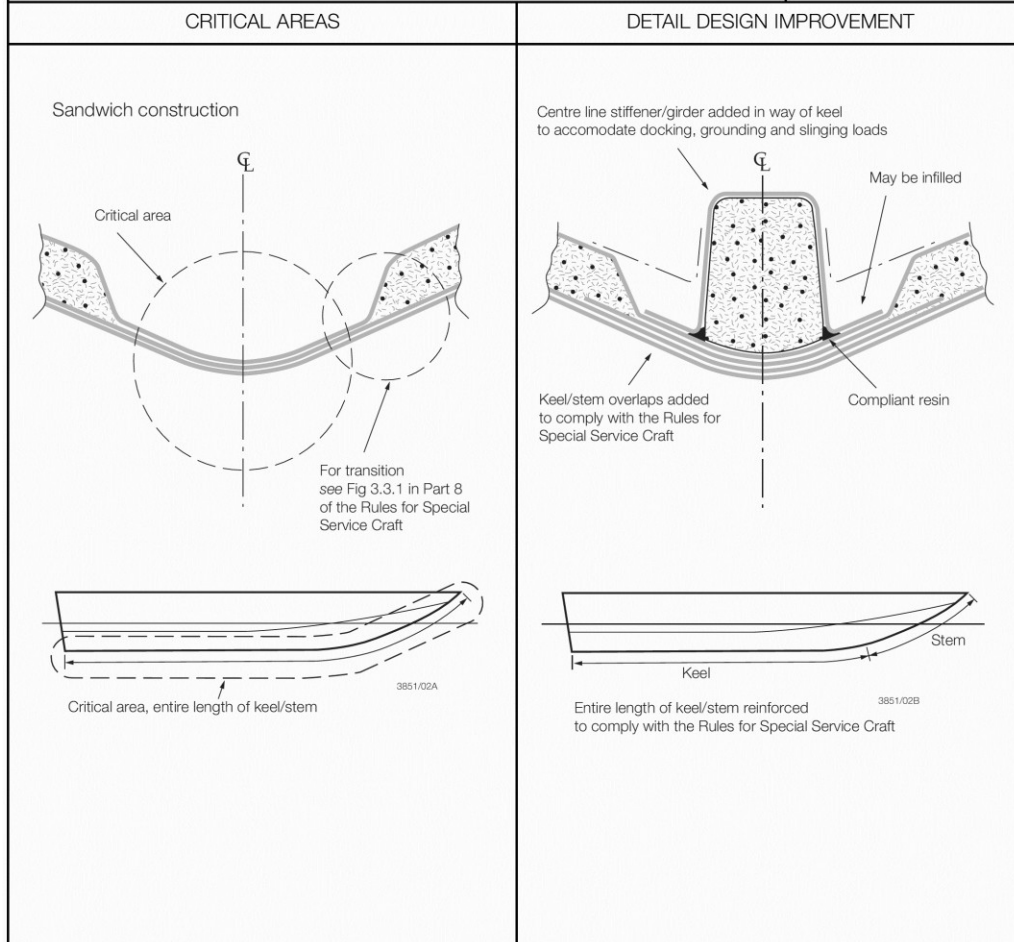
AREA: Hull centreline structure  
 ITEM: Keel/stem reinforcement and keel stiffening

Failure Mechanism            Excess loads due to grounding, docking and slinging.

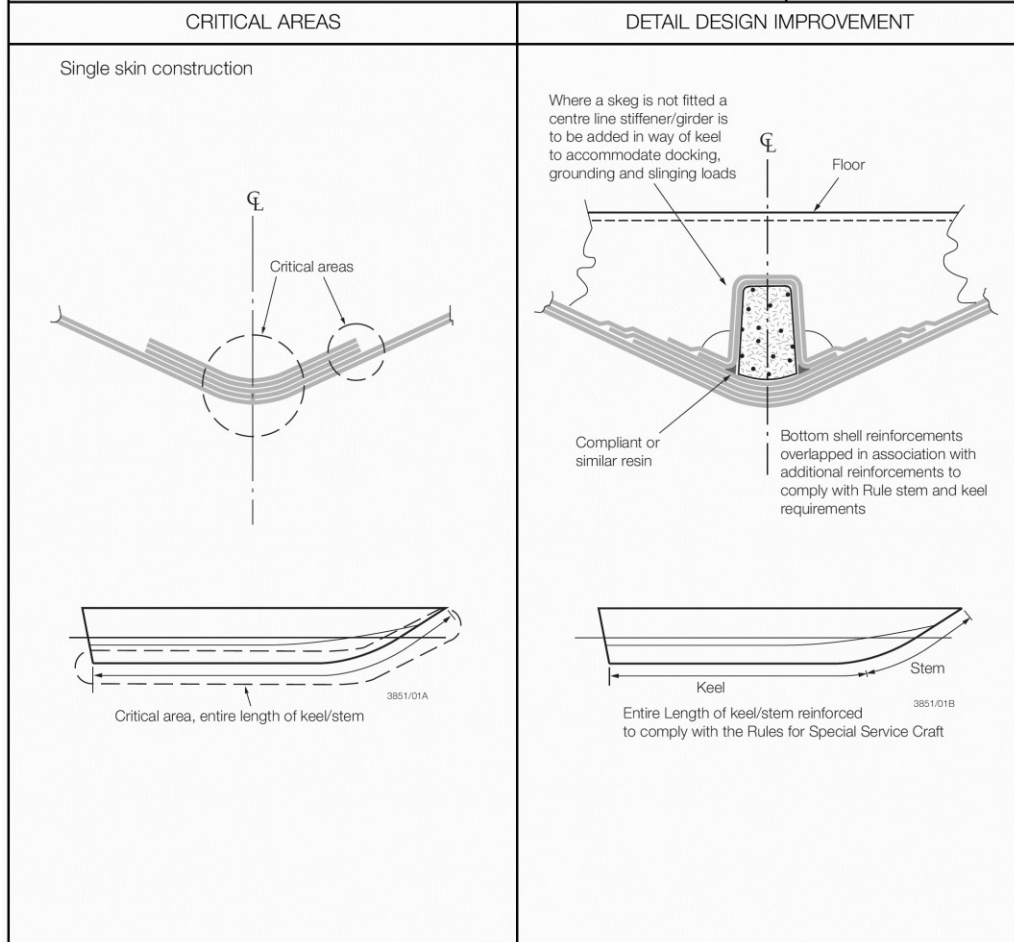
AREA: Hull centreline structure  
 ITEM: Keel/stem reinforcement and keel stiffening

- Failure Mechanism      Excess loads due to grounding, docking and slinging.
- Building Tolerance      All FRP materials to comply with the Rules for Special Service Craft.
- Laminating Requirements      To be in accordance with Part 8 of the Rules for Special Service Craft.

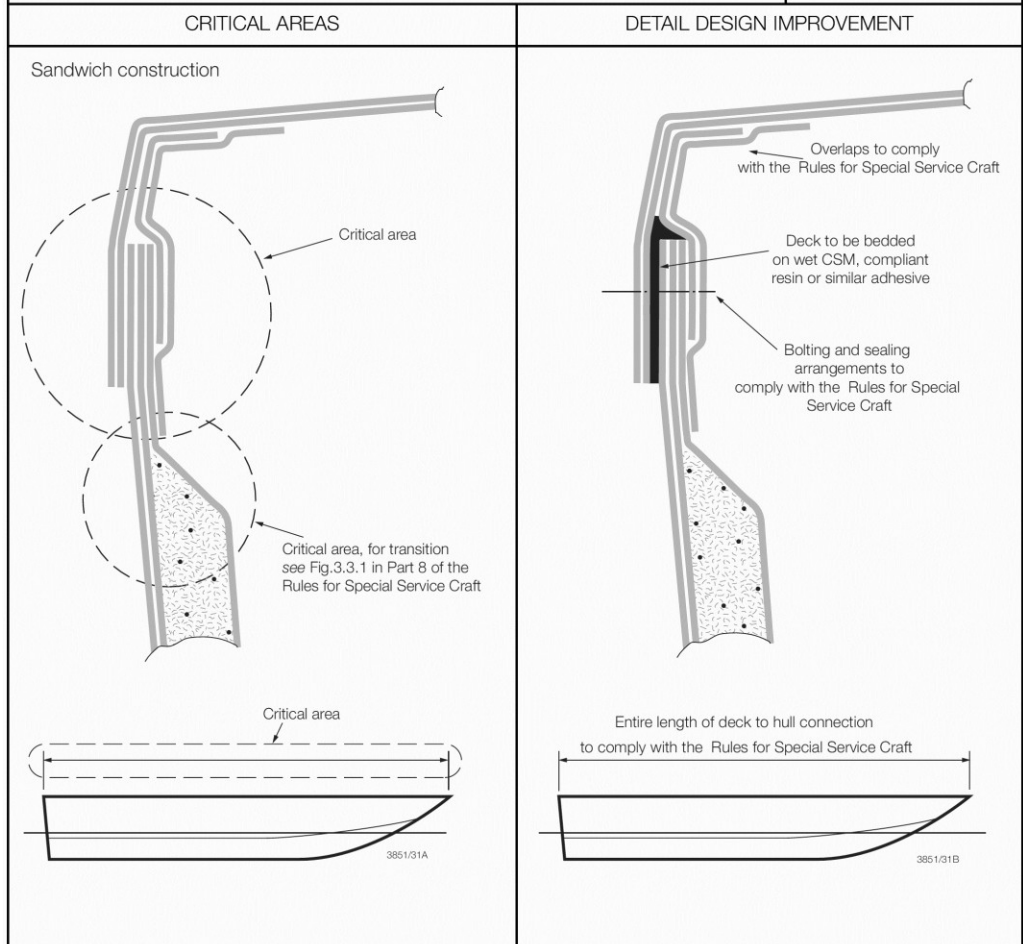
AREA: Hull structure  
 ITEM: Deck to hull connection

Failure Mechanism	Excess loads due to berthing, slinging, impact from green seas and other loadings arising from heavy weather.
Building Tolerance	All FRP material to comply with the Rules for Special Service Craft.
Laminating Requirements	To be in accordance with Part 8 of the Rules for Special Service Craft.

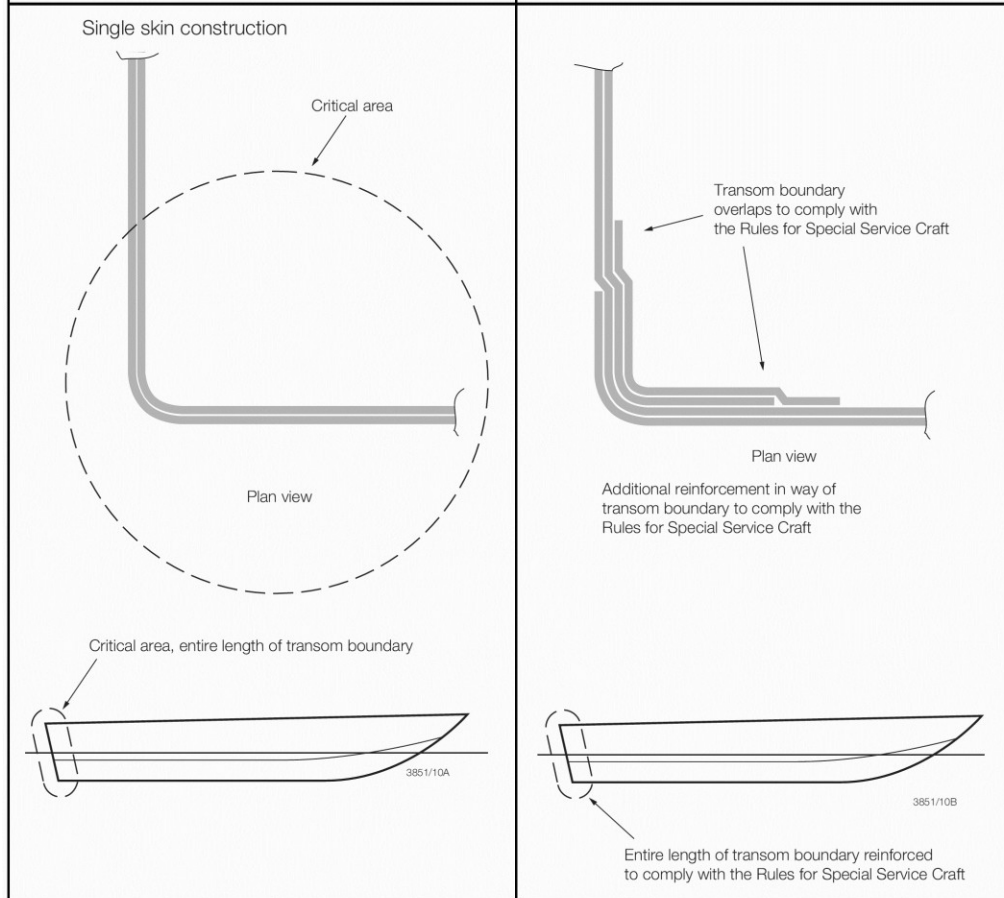
AREA: Hull structure  
 ITEM: Transom boundary

Failure Mechanism            Excess loads due to docking and impact due to berthing.  
 Building Tolerance            All FRP materials to comply with the Rules for Special Service Craft.  
 Laminating Requirements    To be in accordance with Part 8 of the Rules for Special Service Craft.

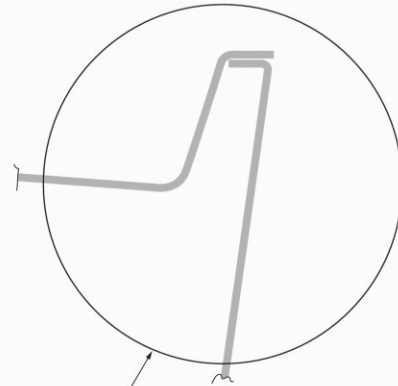
Single skin construction

AREA: Hull structure  
 ITEM: Deck to hull connection

Critical area

| Failure Mechanism | Excess loads due to berthing, slinging, impact from green seas and other loadings arising from heavy weather. |

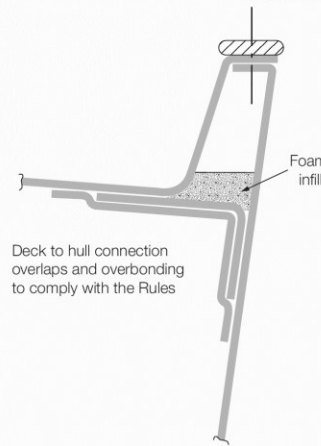
Bolts, nuts and washers to be suitably sealed

Deck to hull connection overlaps and overbonding to comply with the Rules

Deck to hull connection to comply with the Rules

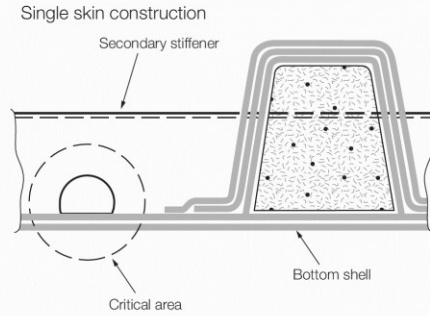
AREA: Hull bottom structure

ITEM: Limber holes

CRITICAL AREAS

- Failure Mechanism Excess loads due to hydrodynamic impact, grounding, docking and slinging leading to stiffener web failure.
- Building Tolerance All FRP materials to be in accordance with the Rules for Special Service Craft.
- Laminating Requirements To be in accordance with Part 8 of the Rules for Special Service Craft.

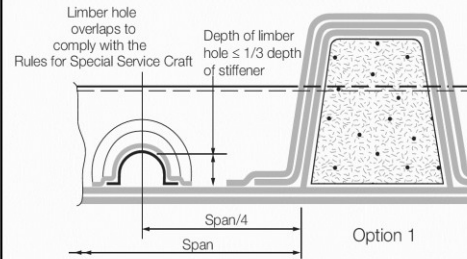
FRP preform bonded to shell and stiffener with compliant resin adhesive

NOTE: PVC preforms to be overlaminated to shell before installation of stiffener

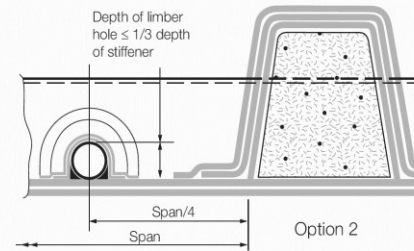
All limber holes to comply with the Rules for Special Service Craft

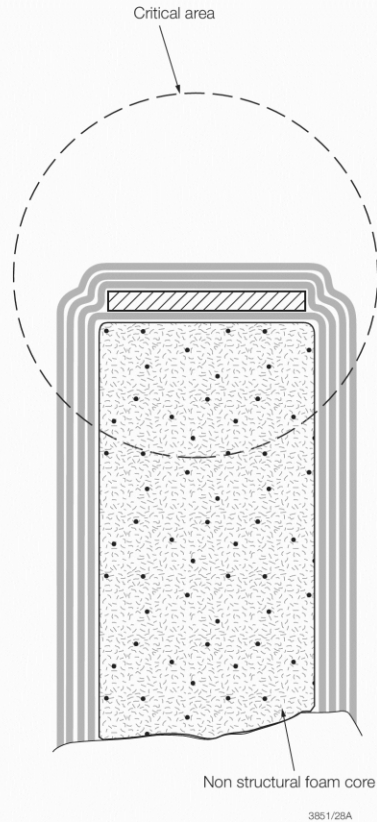
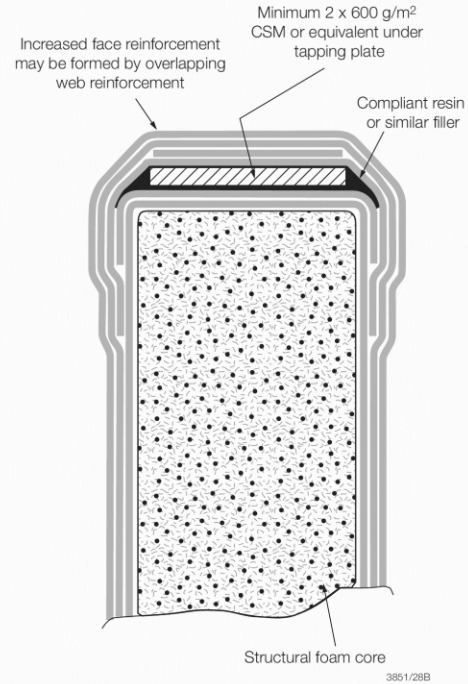
AREA: Hull bottom structure  
 ITEM: Machinery seating, tapping plates

Tapping plate is to be suitably abraded, all sharp edges removed and all corners radiused prior to encapsulating

- Failure Mechanism Engine loadings arising from thrust, torque and mass.
- Building Tolerance All FRP materials to comply with the Rules for Special Service Craft.
- Laminating Requirements To be in accordance with Part 8 of the Rules for Special Service Craft.

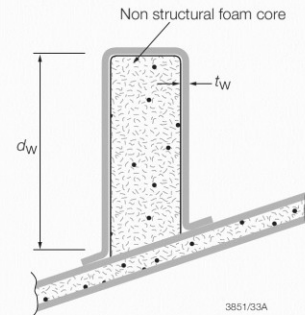
Sandwich construction/single skin construction

AREA: Hull internal structure

ITEM: Deep girders and floors

$t_w$  is to satisfy the Rule requirement for  $d_w$ , see Pt 8, Ch 2.5.9 of the Rules for Special Service Craft

$d_w$  = unsupported web depth  
 $t_w$  = web thickness

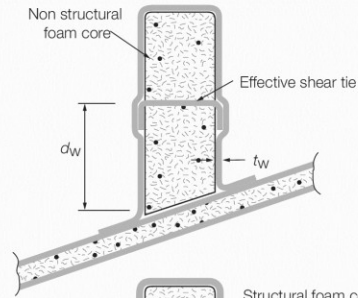
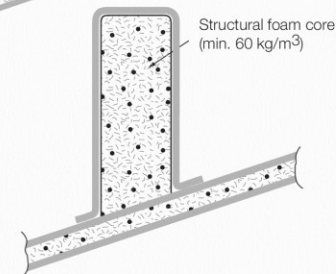
Failure Mechanism Web buckling under design load, docking and berthing loads.

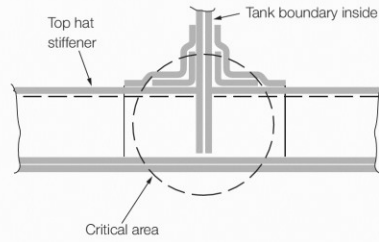
AREA: Hull internal structure  
 ITEM: 'Top-hat' stiffeners penetrating tank boundaries

CRITICAL AREAS

Failure Mechanism      Ingress and permeation of fluid along stiffener.

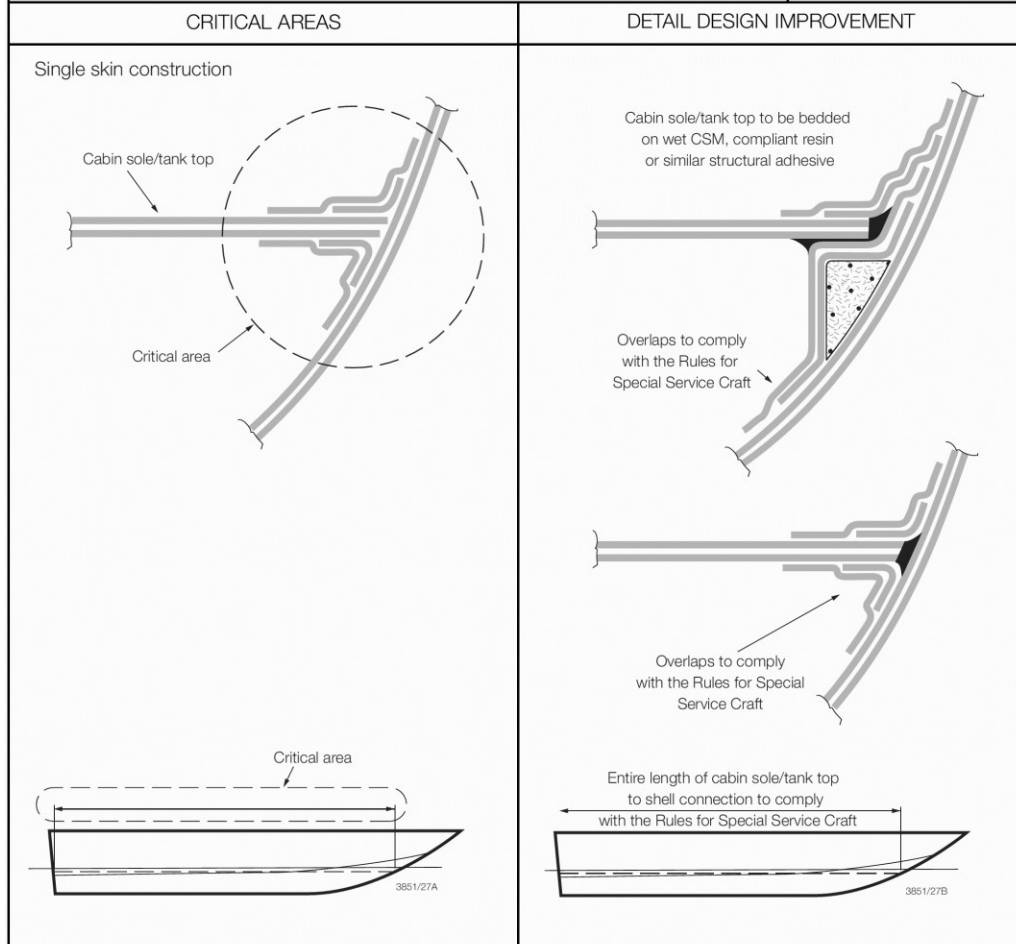
AREA: Hull internal structure  
 ITEM: Lower deck/tank top to bottom shell connection

Failure Mechanism	Excess loads due to impact also hydrostatic pressure where the internal structure forms the boundary of an integral tank.
Building Tolerance	All FRP materials to comply with the Rules for Special Service Craft.
Laminating Requirements	To be in accordance with Part 8 of the Rules for Special Service Craft.

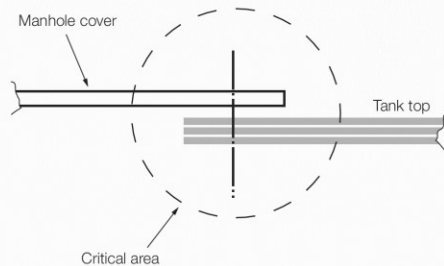
AREA: Hull internal structure  
 ITEM: Integral tanks access manholes

CRITICAL AREAS

- Failure Mechanism            Leakage under hydrostatic pressure.
- Building Tolerance            All FRP material to comply with the Rules for Special Service Craft.
- Laminating Requirements    To be in accordance with Part 8 of the Rules for Special Service Craft.

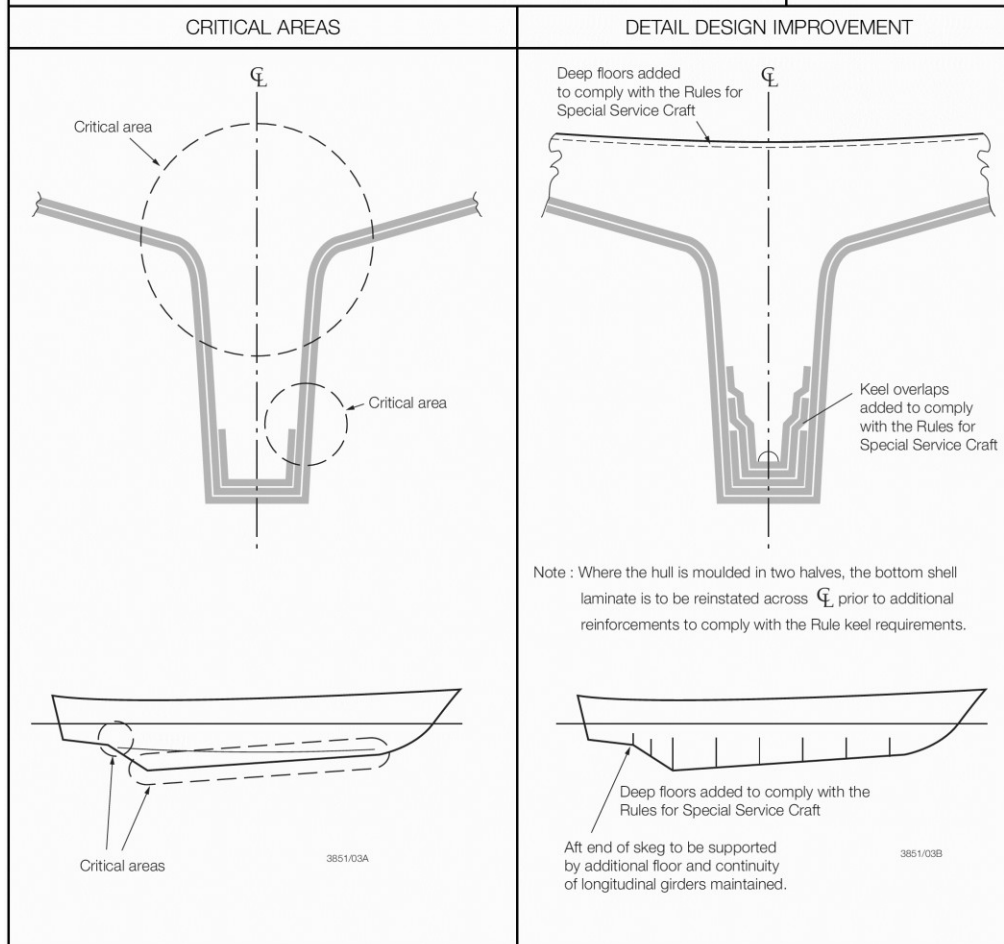
AREA: Skeg (open type)  
 ITEM: Skeg stiffening and reinforcement

Failure Mechanism	Excess loads due to grounding, docking, slinging and hydrostatic pressure.
Building Tolerance	All FRP materials to comply with the Rules for Special Service Craft.
Laminating Requirements	To be in accordance with Part 8 of the Rules for Special Service Craft.

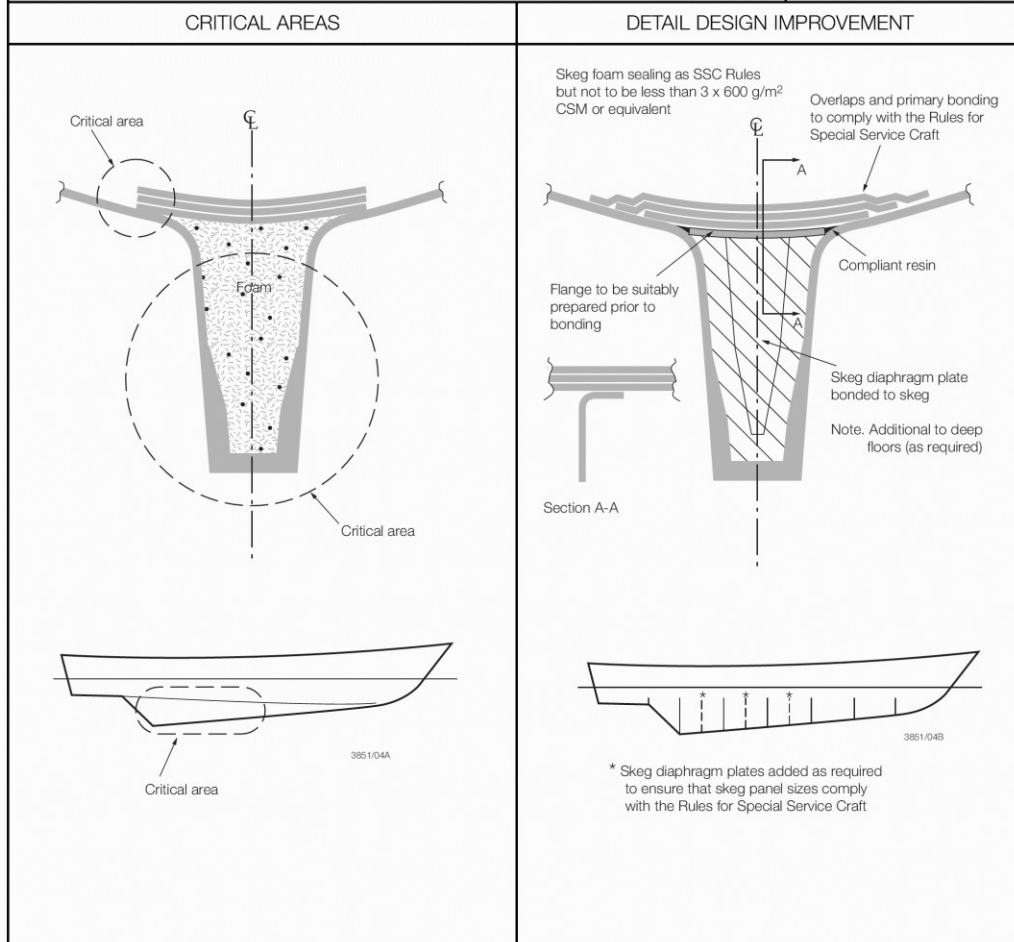
AREA: Skeg (closed type)  
 ITEM: Skeg diaphragm plates and sealing laminate

Failure Mechanism      Excess loads due to grounding, docking, slinging and hydrostatic pressure both externally and internally in the case of integral tanks.

Building Tolerance      To align with bottom framing. All FRP materials to comply with the Rules for Special Service Craft.

Laminating Requirements      To be in accordance with Part 8 of the Rules for Special Service Craft.

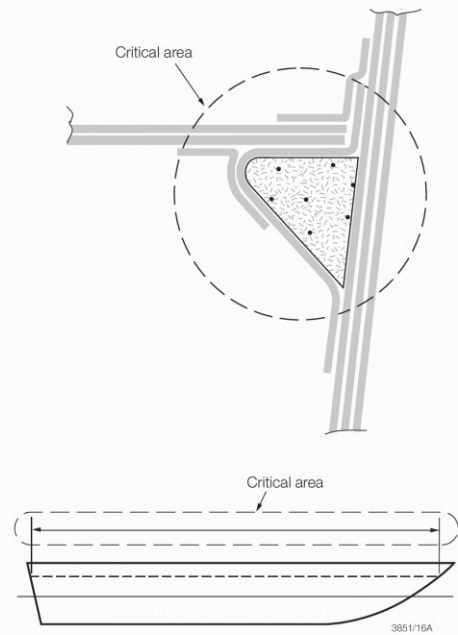
DETAIL DESIGN IMPROVEMENT

- Failure Mechanism            Excess loads due to berthing and slinging.
- Building Tolerance            All FRP material to comply with the Rules for Special Service Craft.
- Laminating Requirements    To be in accordance with Part 8 of the Rules for Special Service Craft.

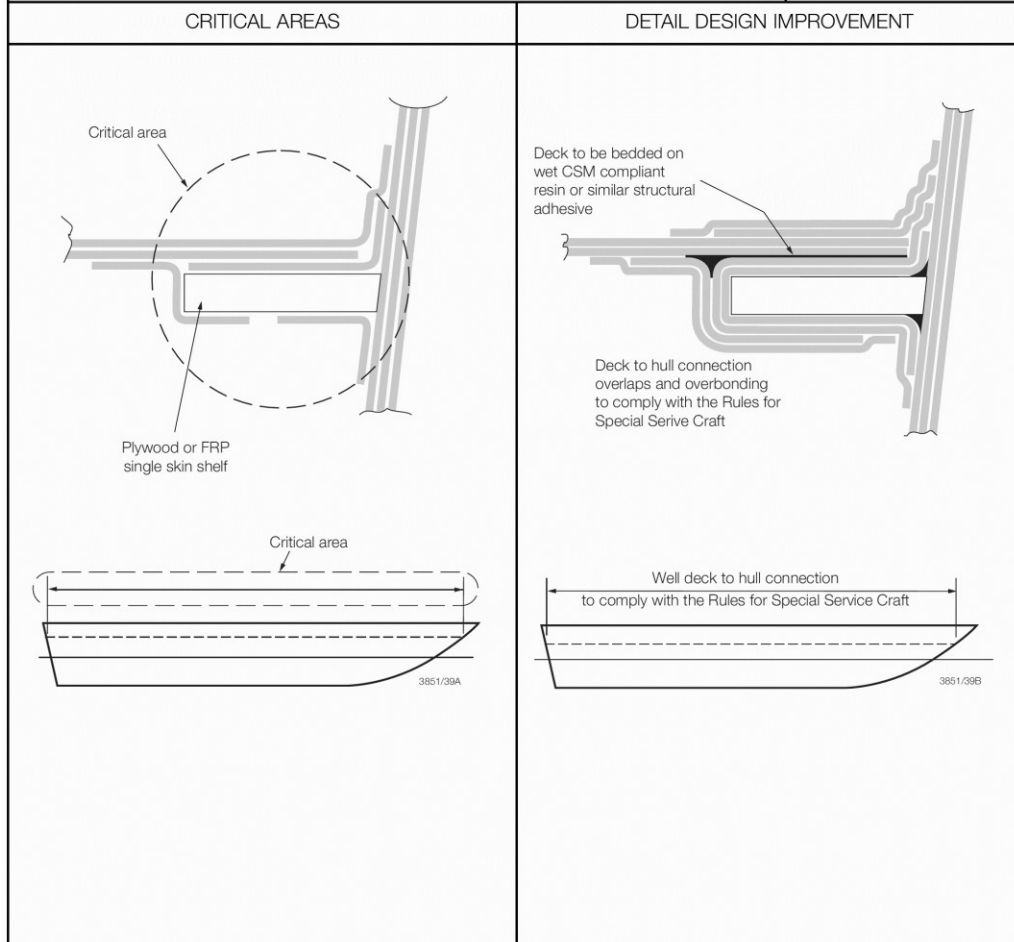
AREA: Deck structure  
 ITEM: Well deck, lower/sole deck to hull connection

Failure Mechanism            Excess loads due to berthing and slinging.
