# COSTRUZIONI NAVALI II

**(materiali compositi: dettagli costruttivi)**

# Guidance Notes for the Classification of Special Service Craft

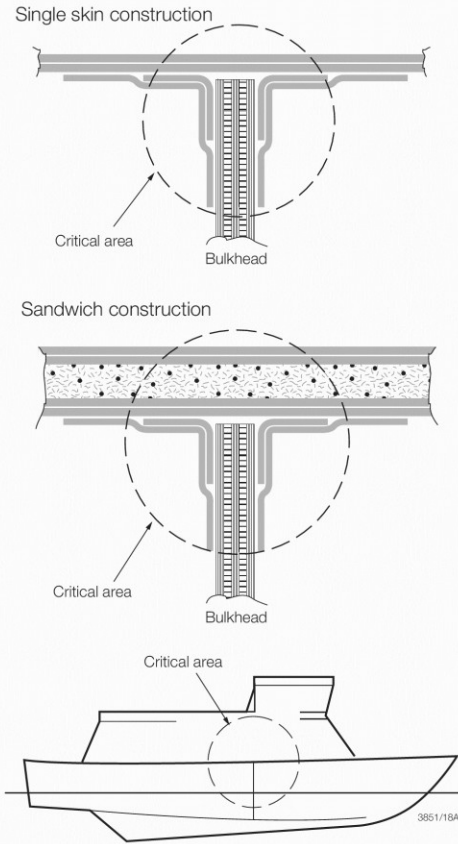
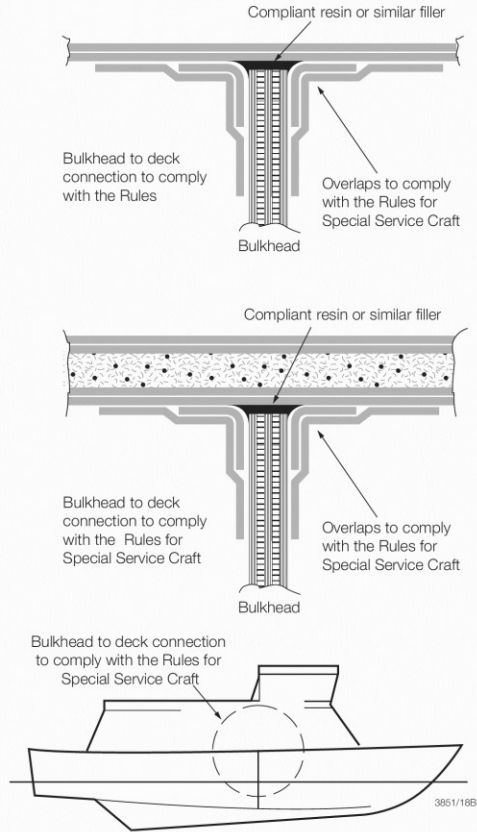
DETAIL DESIGN IMPROVEMENT

| Failure Mechanism | Excess loads due to berthing, slinging and impact. |

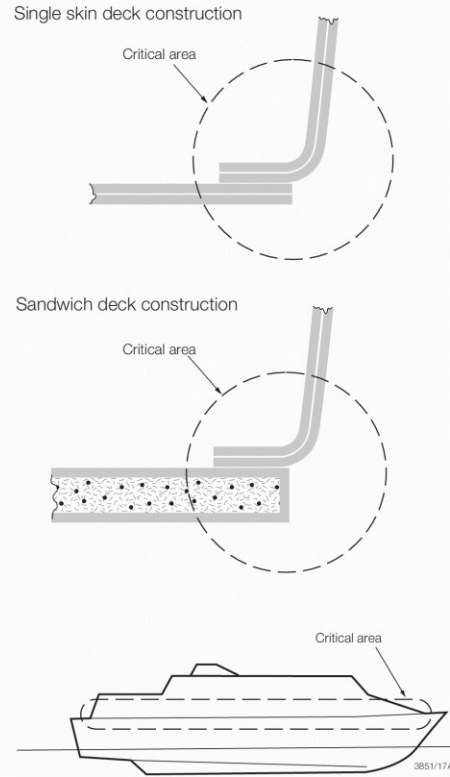
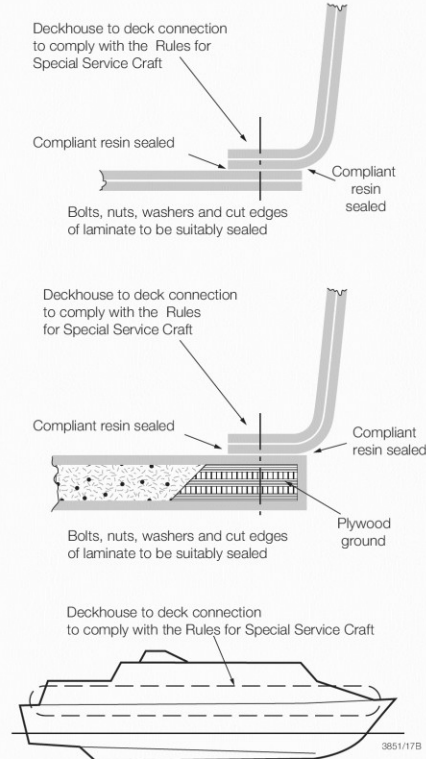
DETAIL DESIGN IMPROVEMENT

Failure Mechanism Excess loads due to berthing, slinging, impact from green seas and other loads arising from heavy weather.
